Treatment of a 17th-Century Anglo-Dutch Military Portrait: Reflecting on an Unexpected Lining Process

Josephine Ren, Paintings Graduate Fellow, Class of 2024 | Fiona Beckett, Associate Professor of Paintings Conservation
Patricia H. and Richard E. Garman Art Conservation Department, SUNY Buffalo State University

American Institute of Conservation
52nd Annual Meeting, May 2024

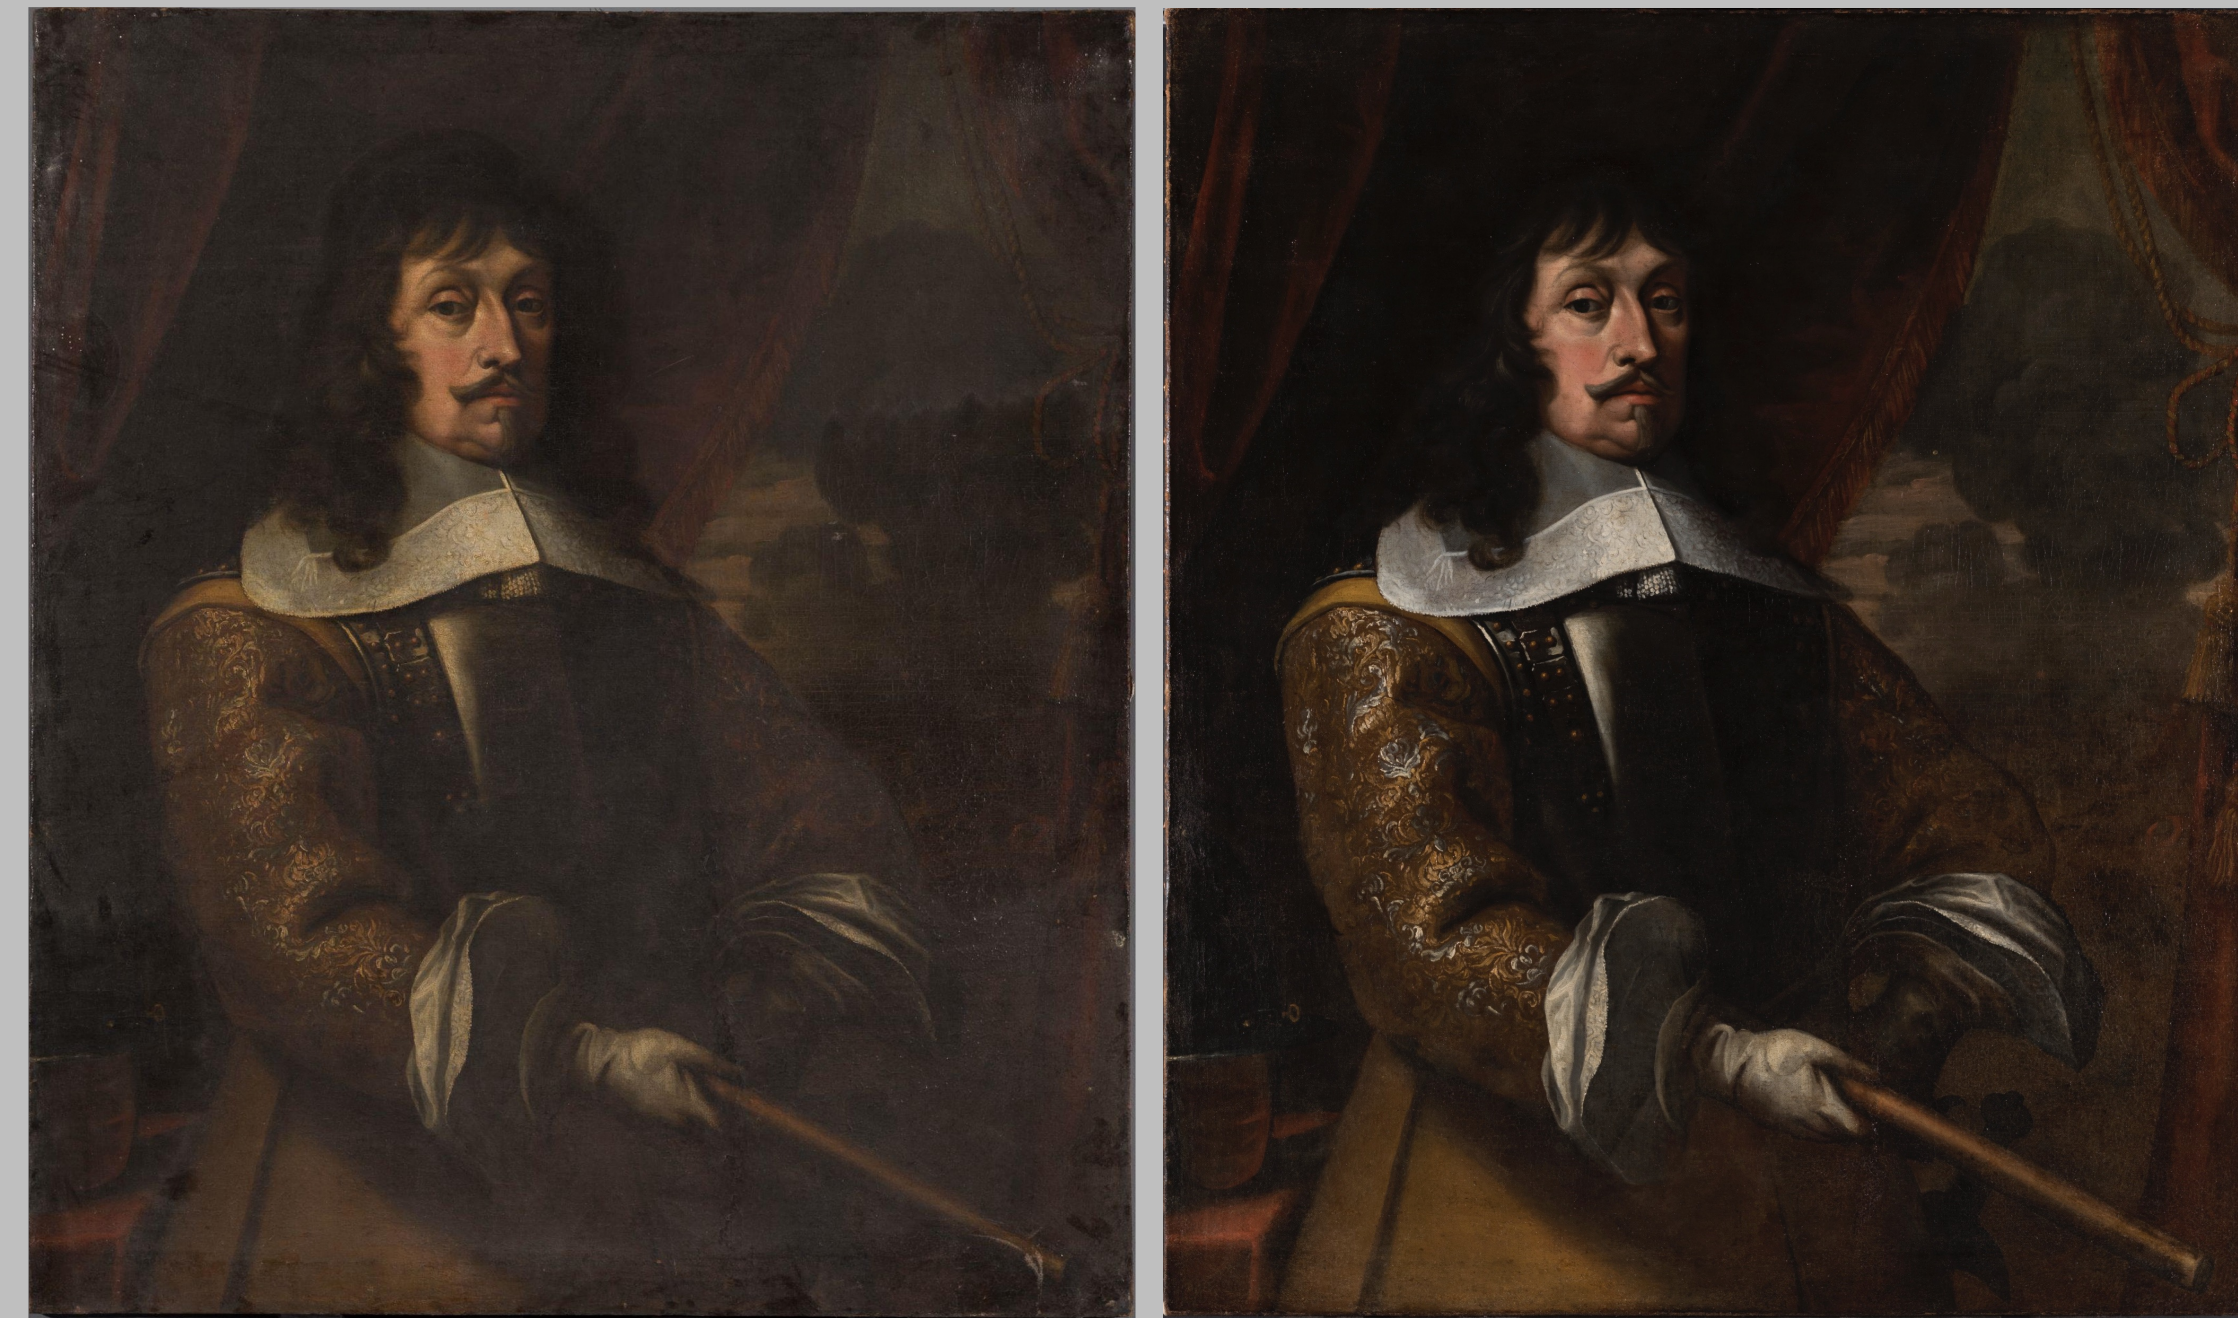
A 17th-c (est.) Anglo-Dutch military portrait (44 x 37 1/8 in.) from the Memorial Art Gallery by an unknown artist was brought to the Garman Art Conservation Department for conservation research and treatment in 2022. The oil on canvas painting exhibited a range of condition issues, including structural instabilities and aesthetic disfigurements alongside previous restoration campaigns. A technical study was completed in conjunction with conservation treatment which improved the overall structural integrity and visual appearance of the artwork. The lining posed practical questions about the latest BEVA® 371a formulation.

Figs. 1-2: Before treatment (left) and after treatment (right), front, normal illumination.

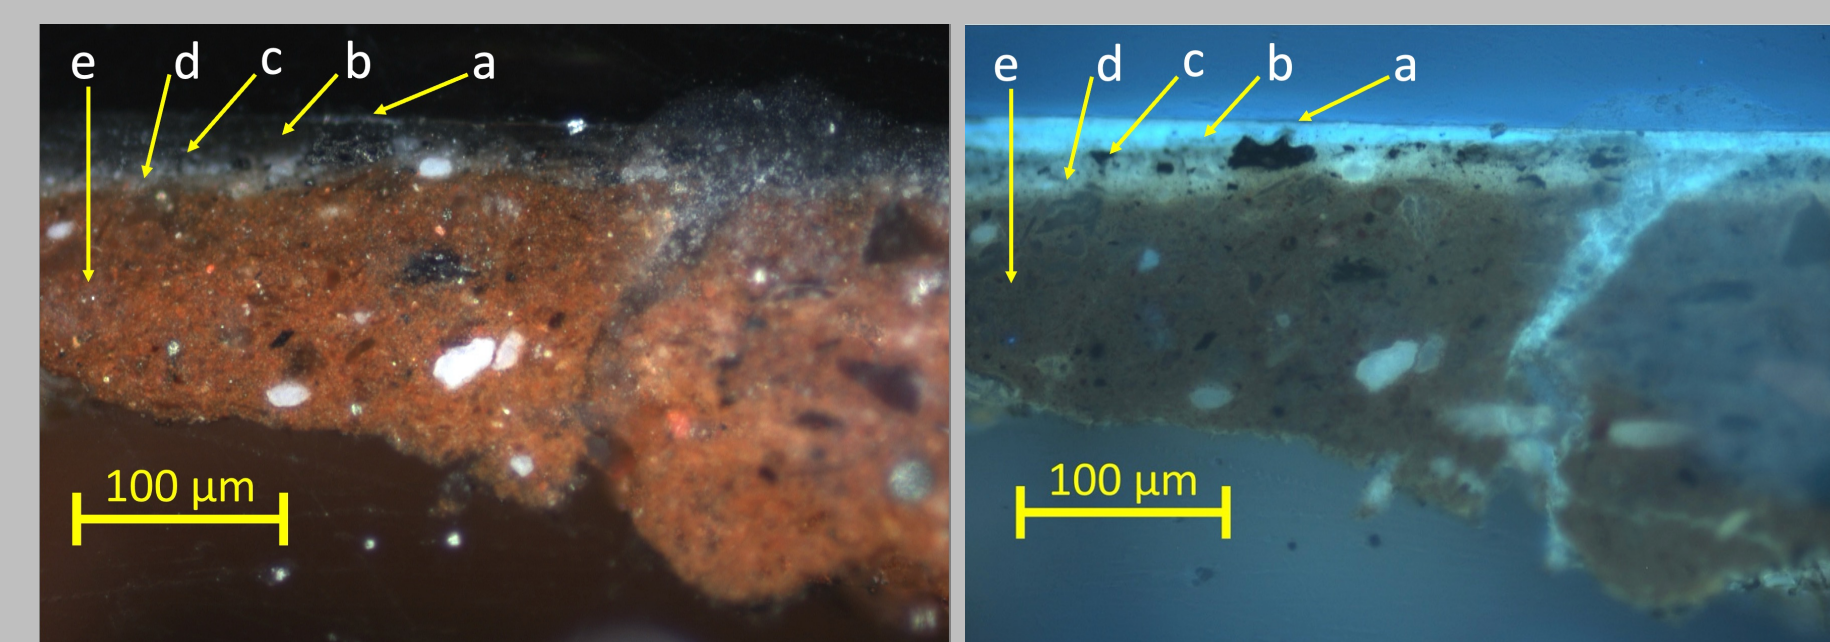
Figs. 5-6: Cross-section micrographs, darkfield (left) and UV (right) illumination, indicating layers of dirt (a), varnish layer (b), black or brown pigmented layer (c), white pigmented layer (d), and red preparatory layer (e).

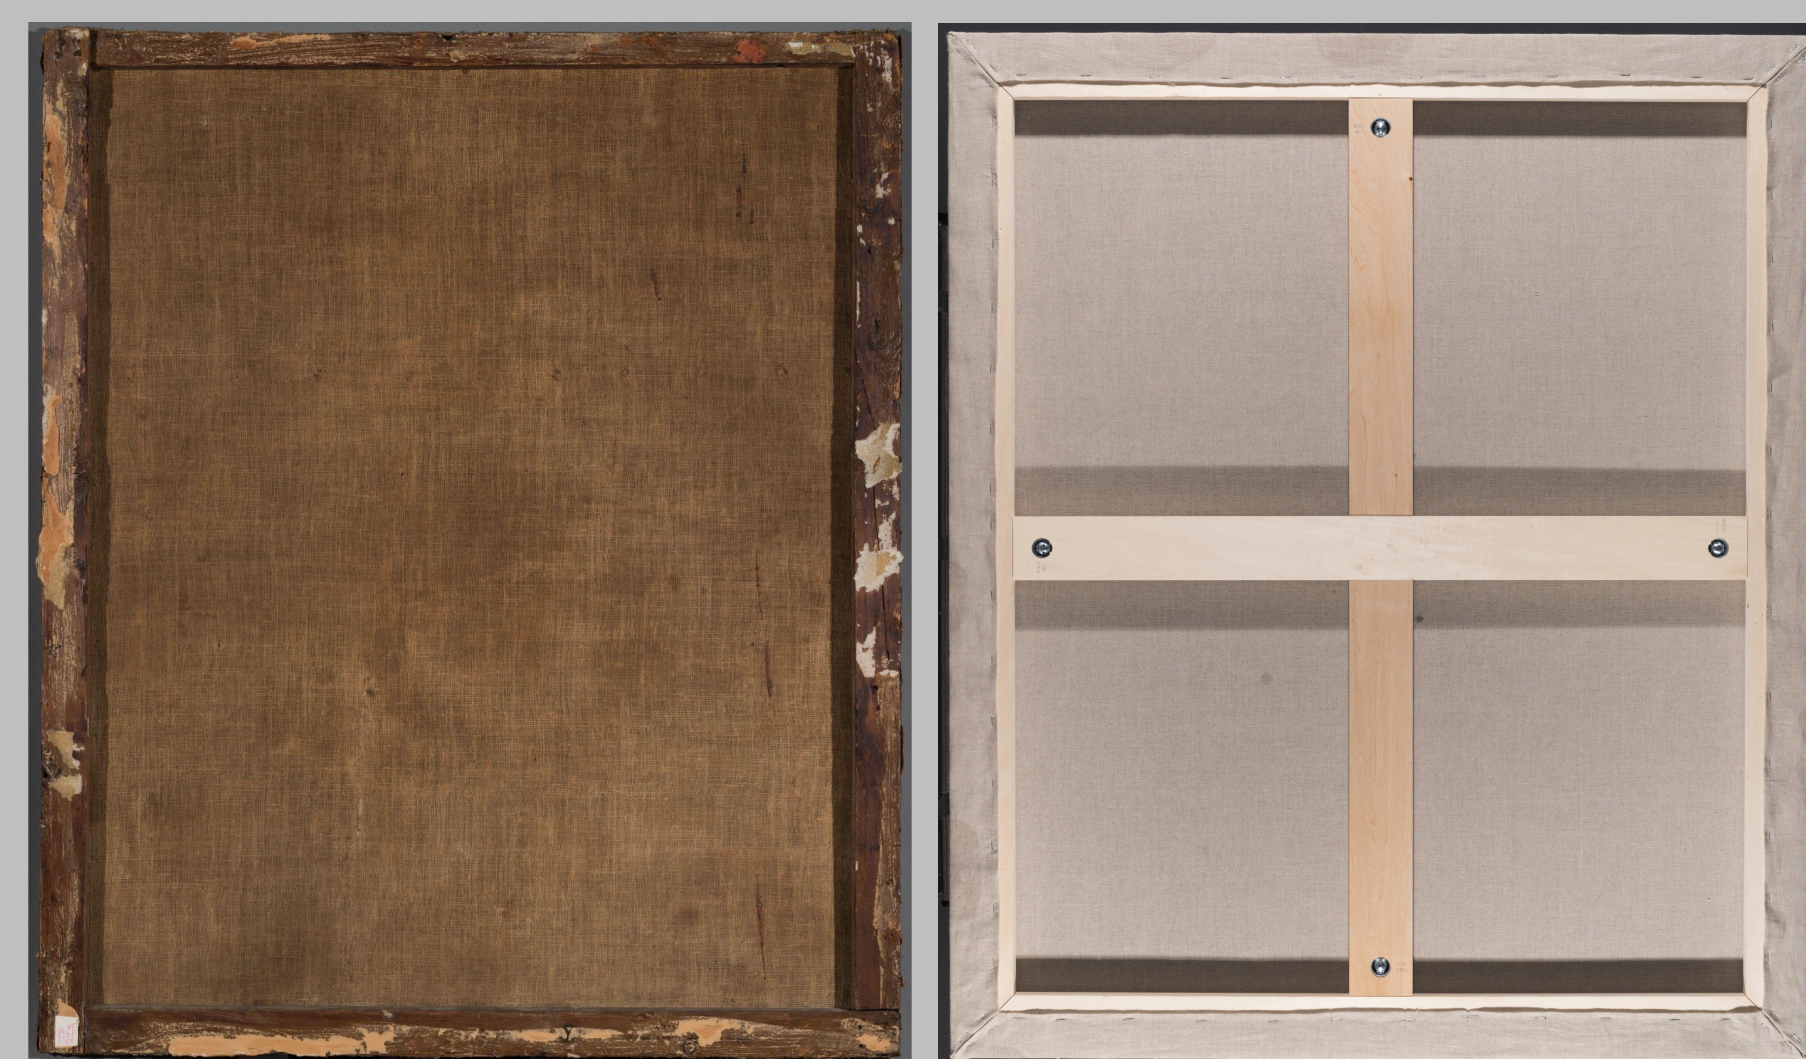
Figs. 3-4: Before treatment (left) and after treatment (right), back, normal illumination.

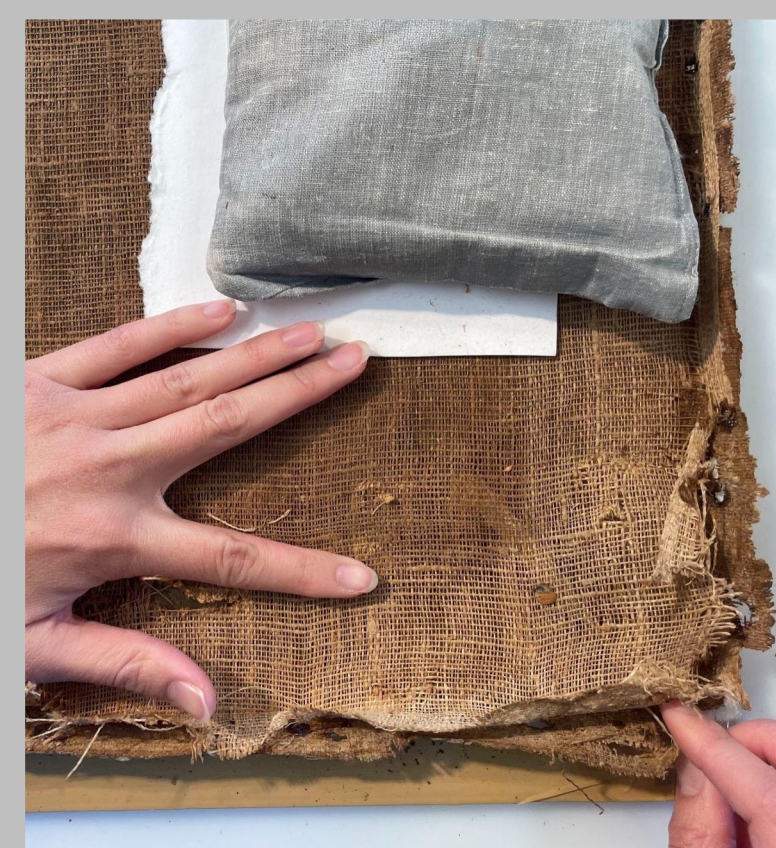
Fig. 7: Removal of old glue lining.

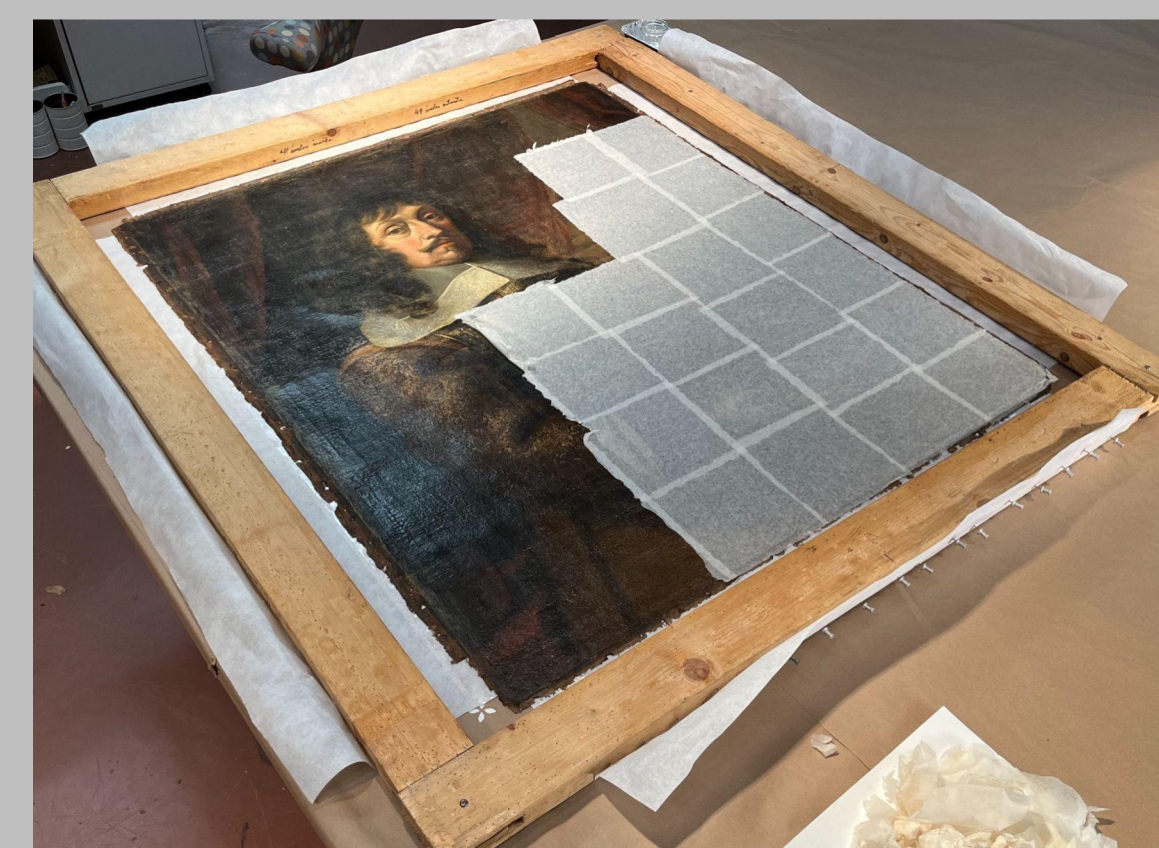
Fig. 8: Removing facing after lining removal.

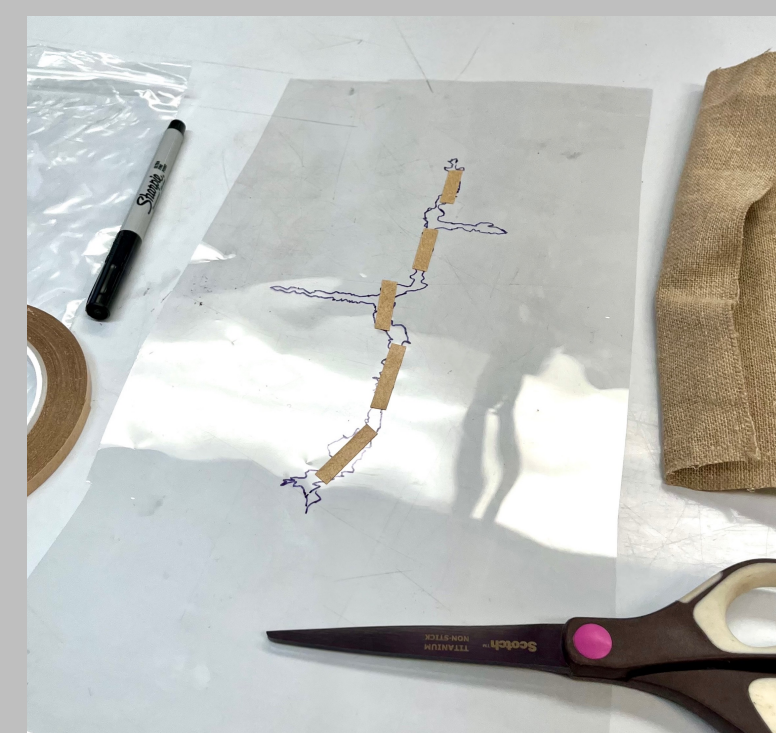
Fig. 9: Creating canvas insert.

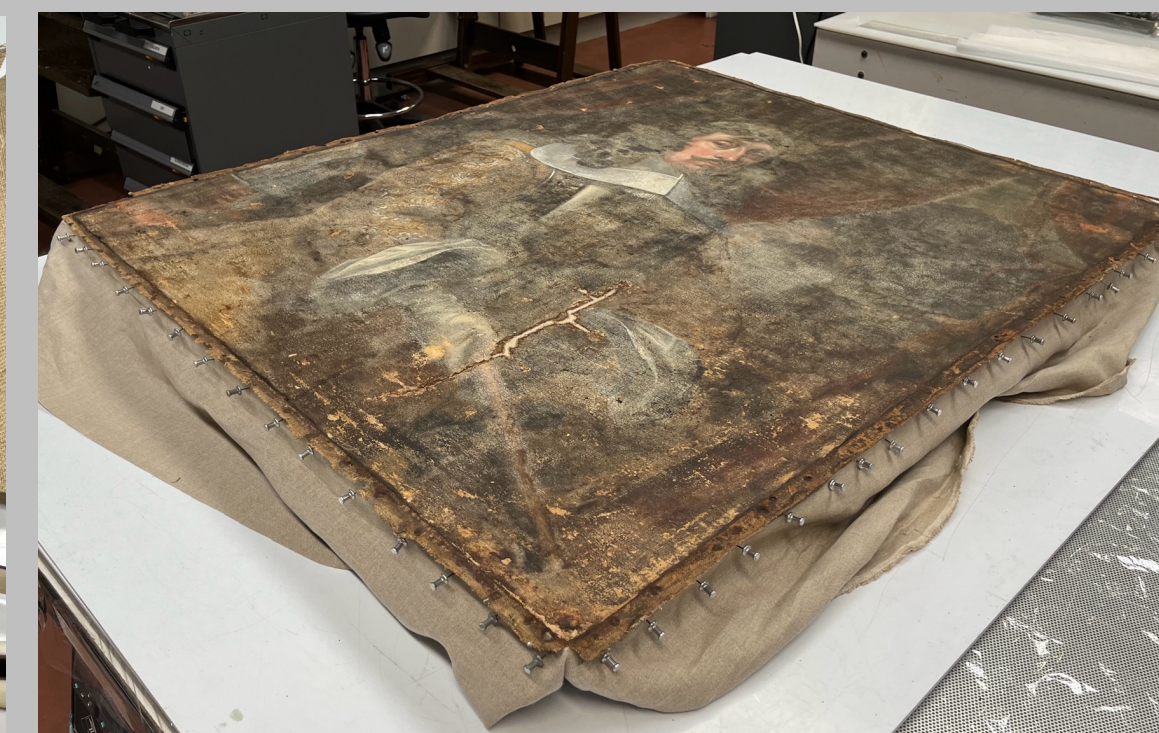
Fig. 10: Re-tensioning lined painting.

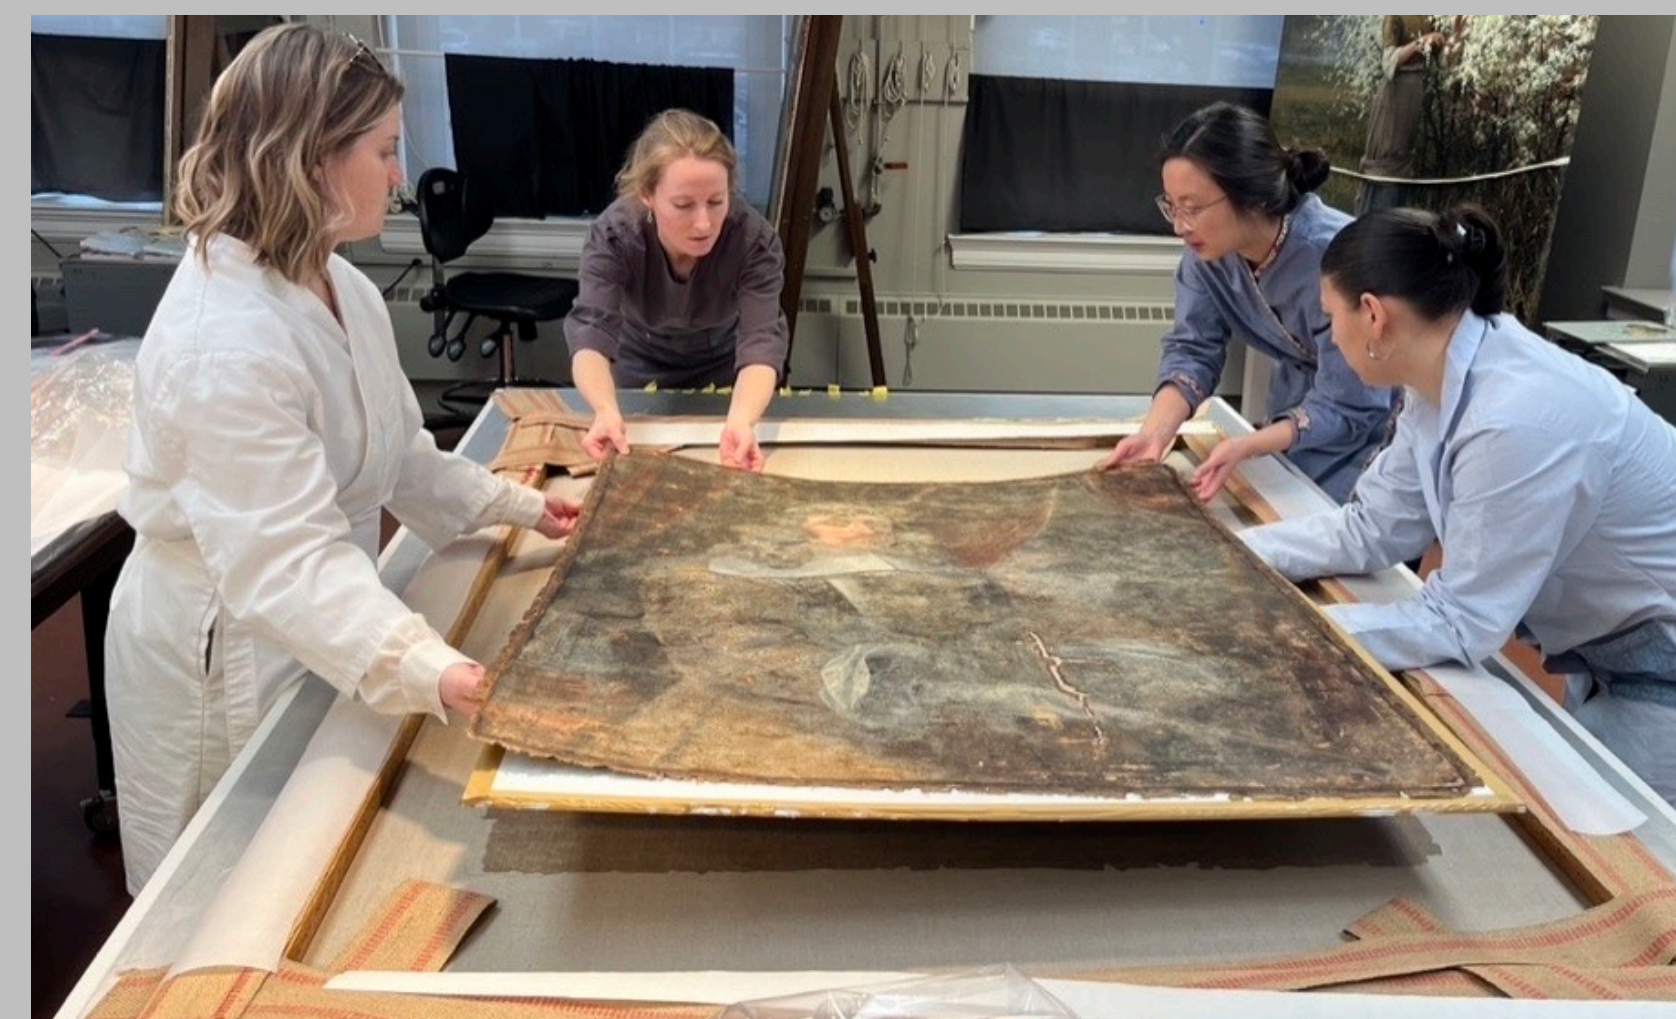
Fig. 11: Positioning painting over BEVA® 371a and canvas on vacuum table.

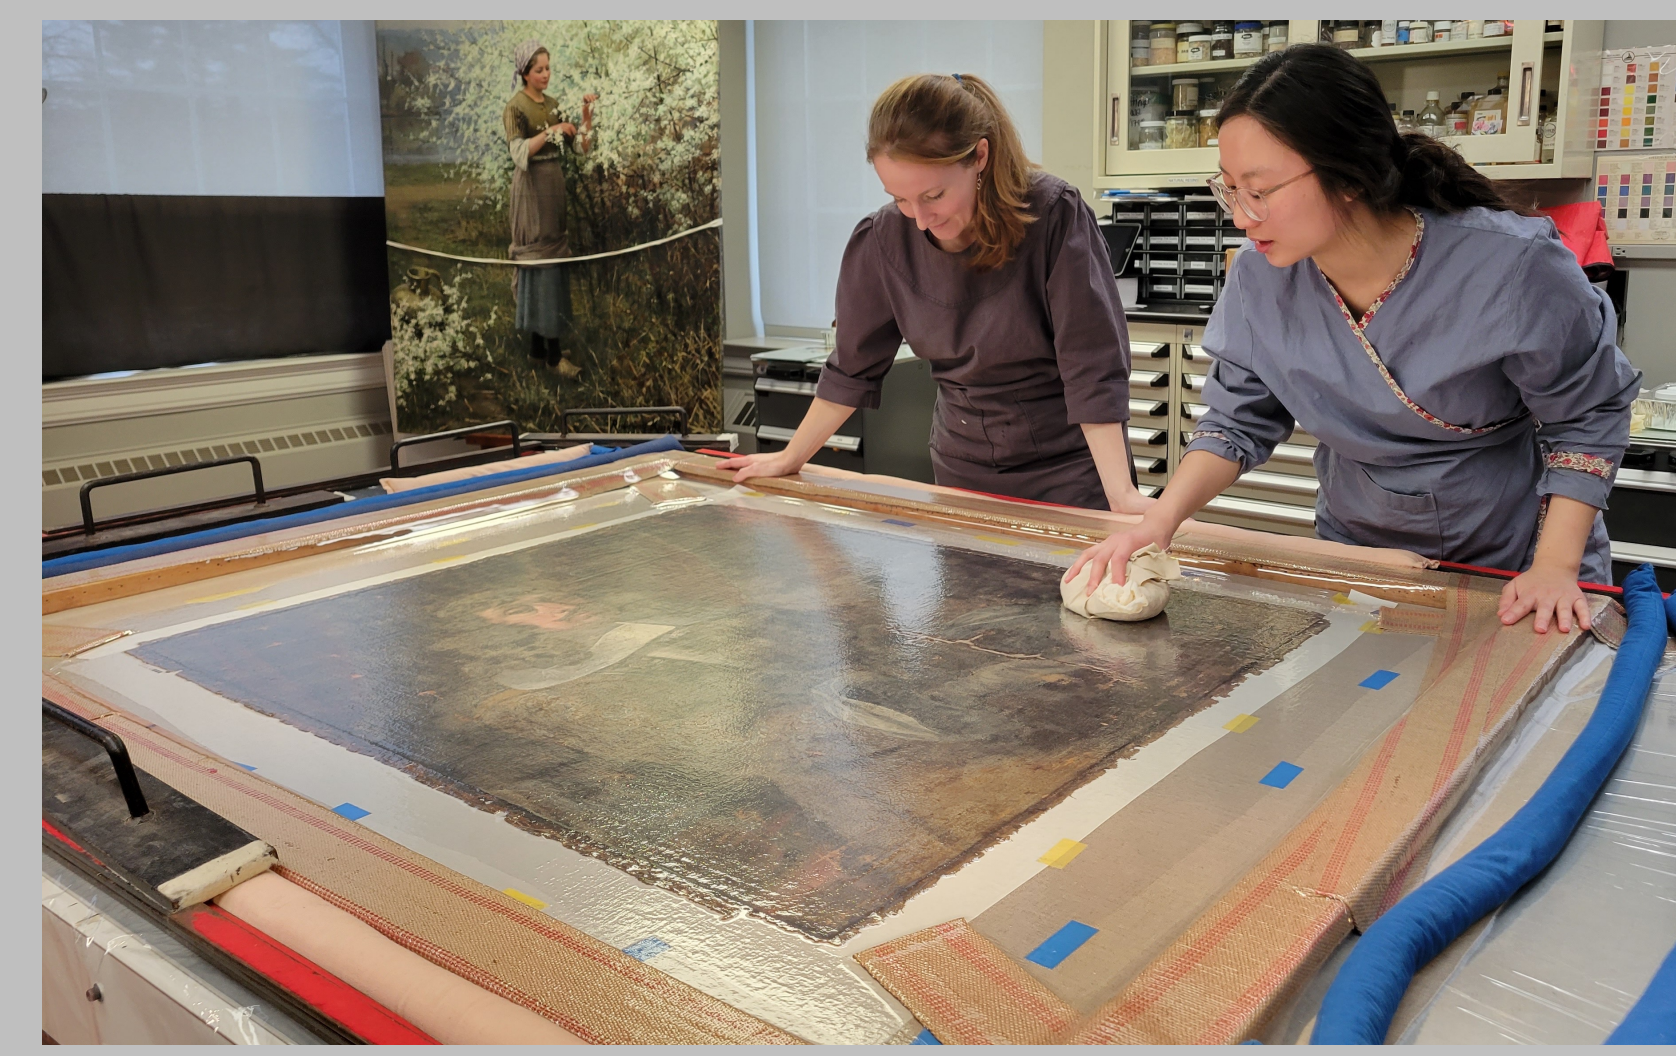
Fig. 12: Massaging painting during lining to encourage flow of additional liquid BEVA® 371a applied as consolidant.

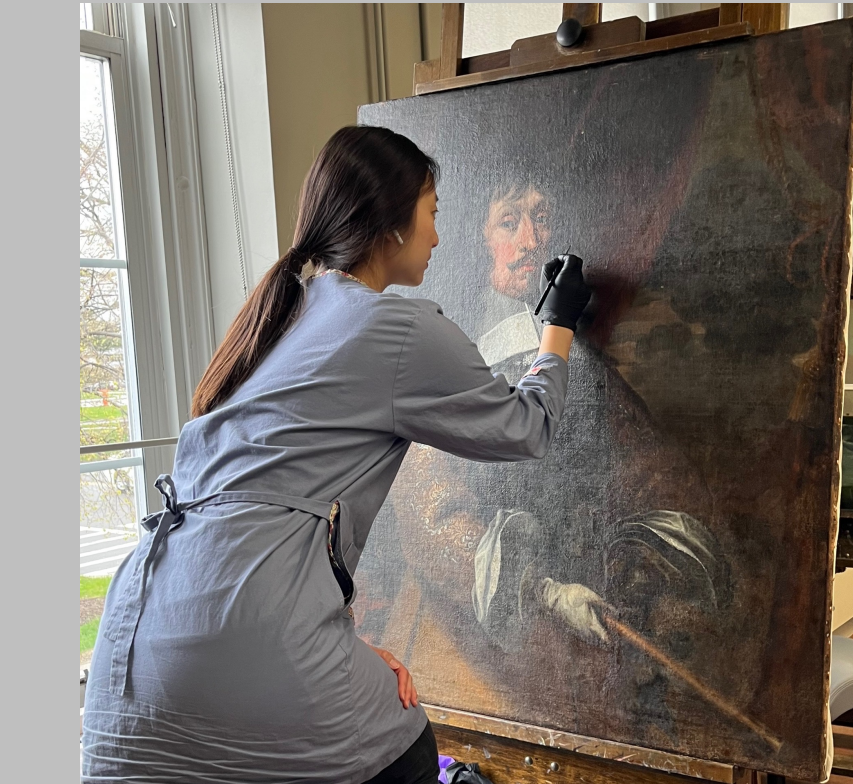
Fig. 15: During Inpainting.

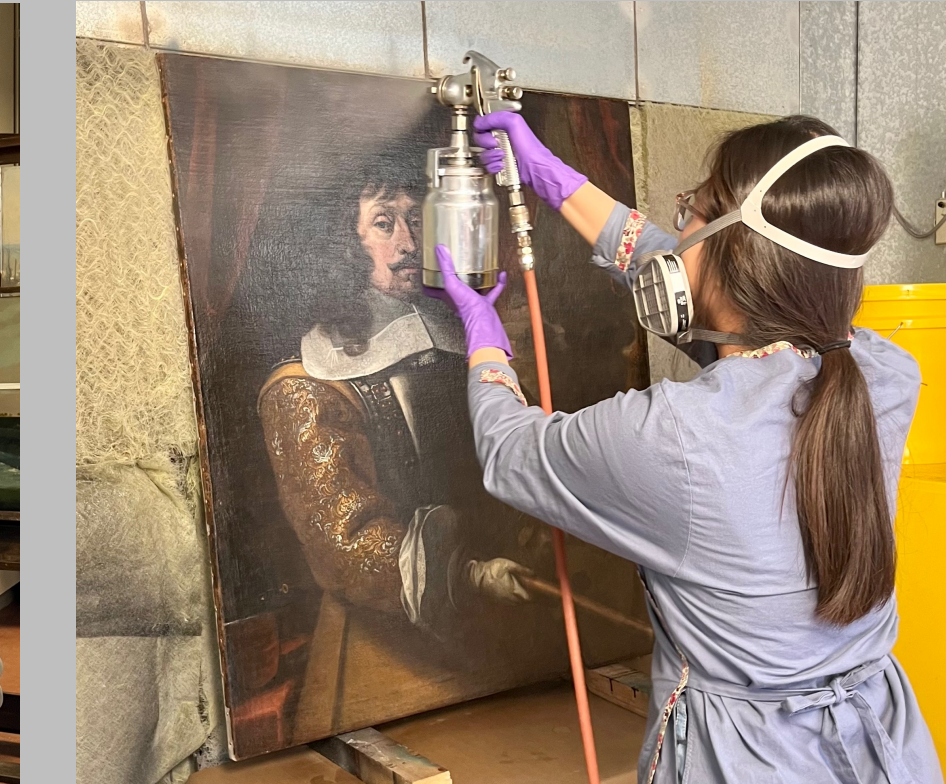
Fig. 16: Spray application of varnish.

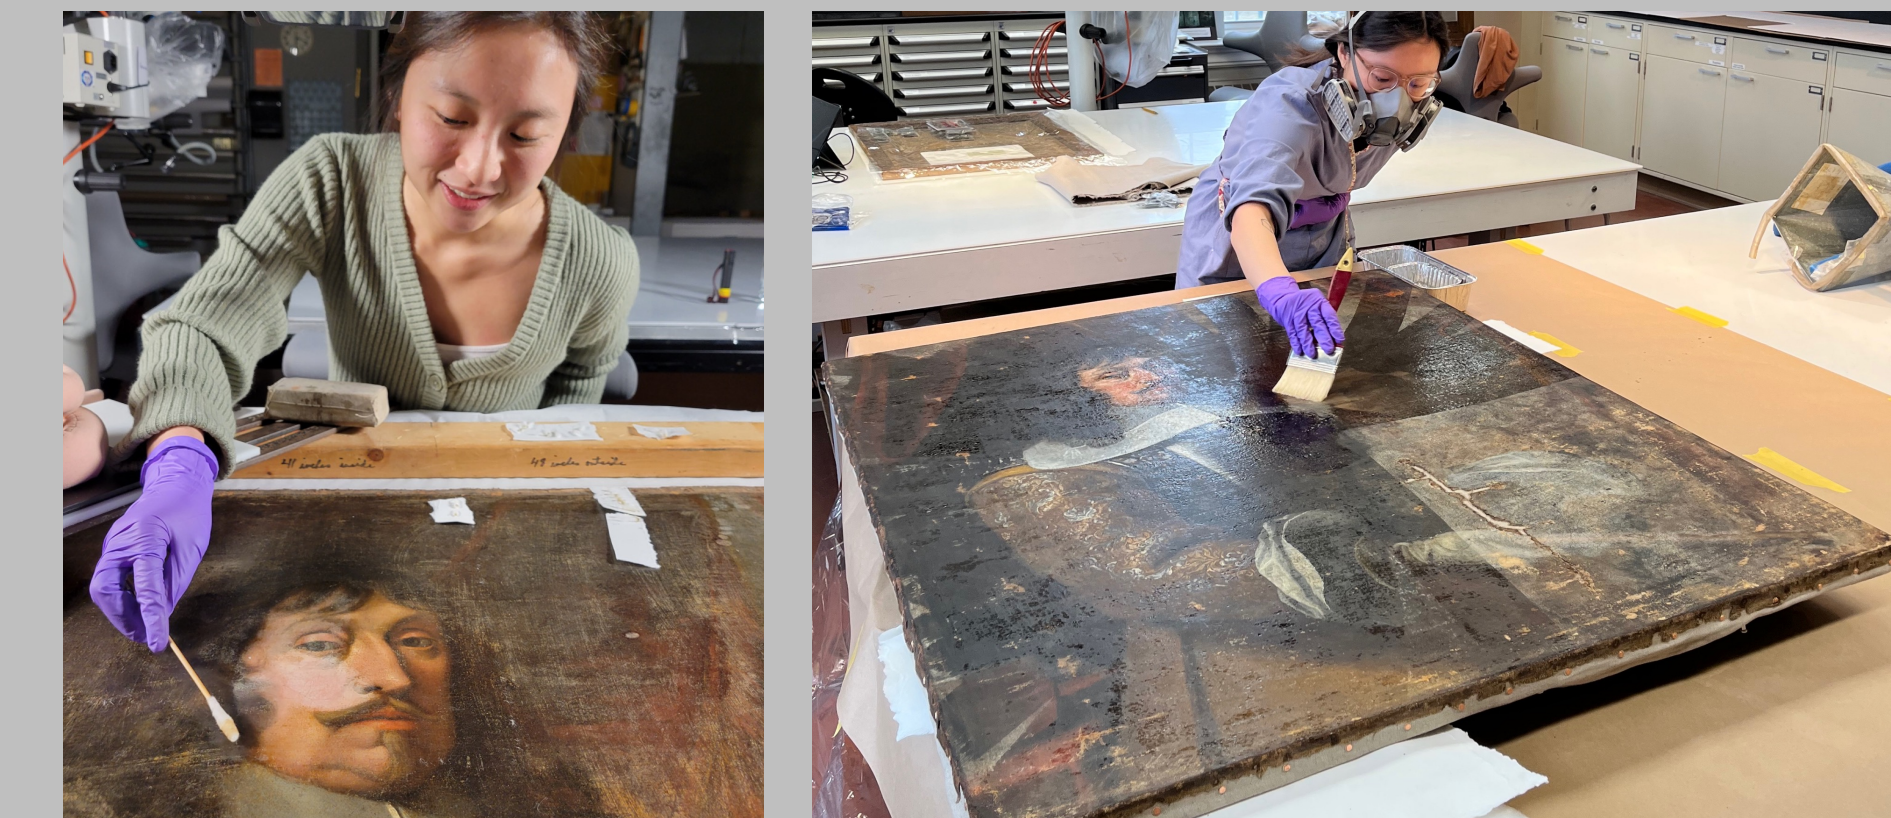
Figs. 13-14: Removing aged varnish (left); brushing initial varnish application (right).

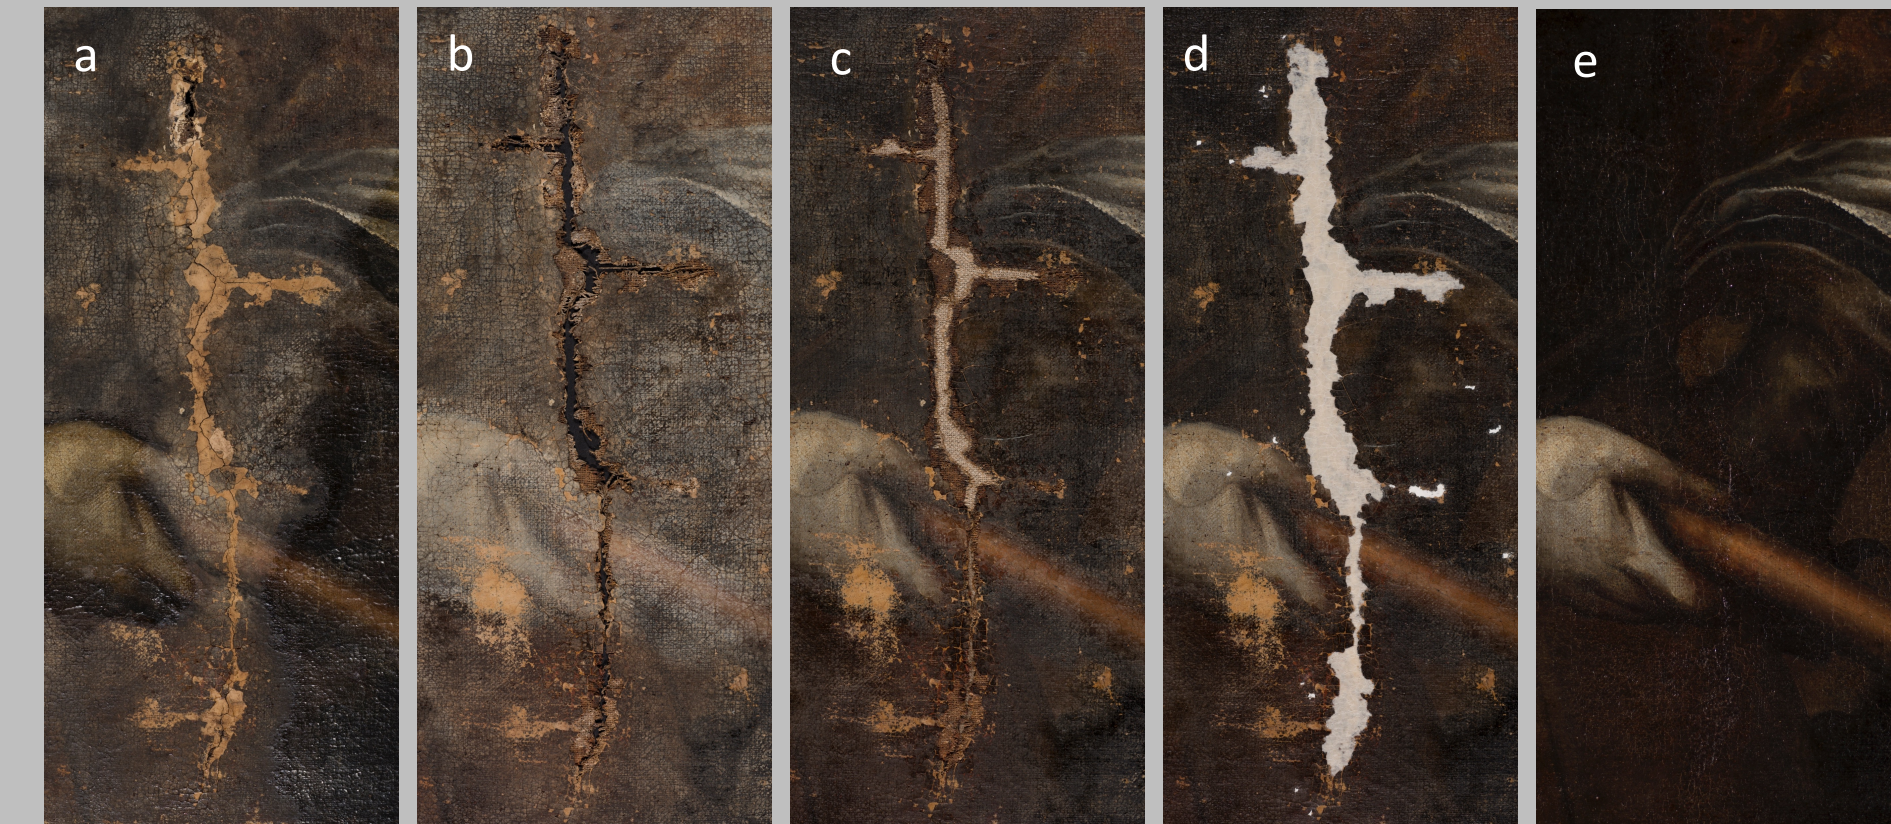
Fig. 17: Detail of treatment of major tear. Left to right: varnish and overpaint removed (a), old fill removed (b), repaired tear (c), filled (d), after treatment (e).

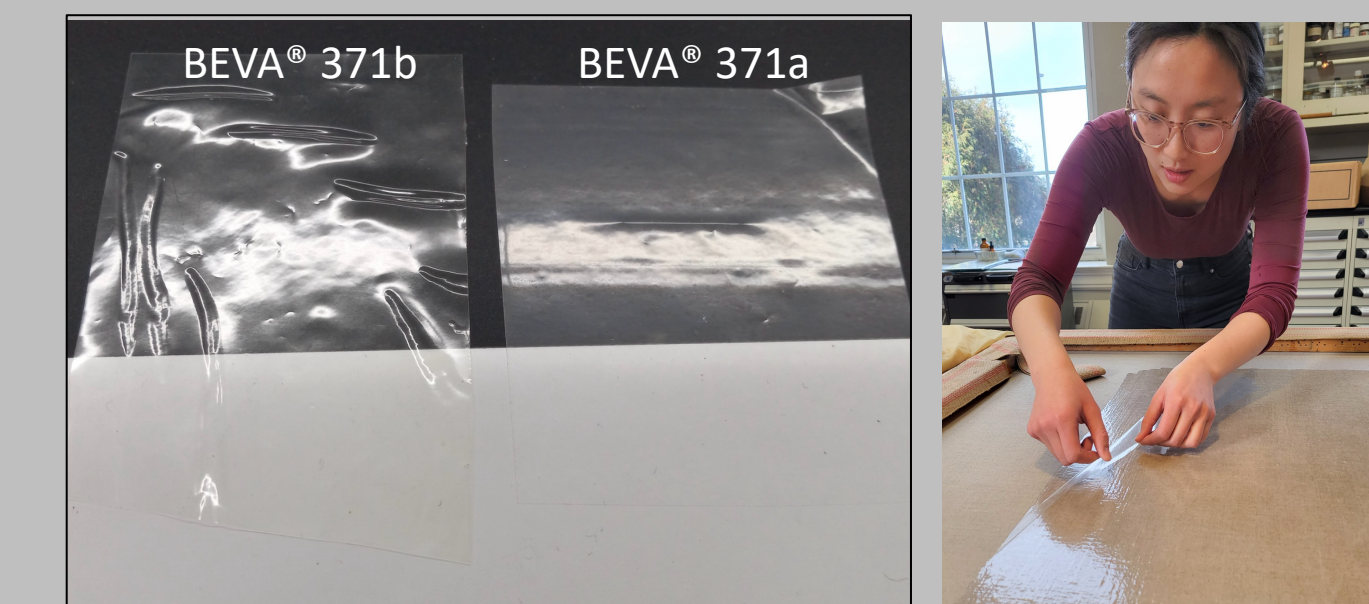
Fig. 18: BEVA® 371b (left) and 371a (right) films. Note slight yellowish color of 371b related to the resin.

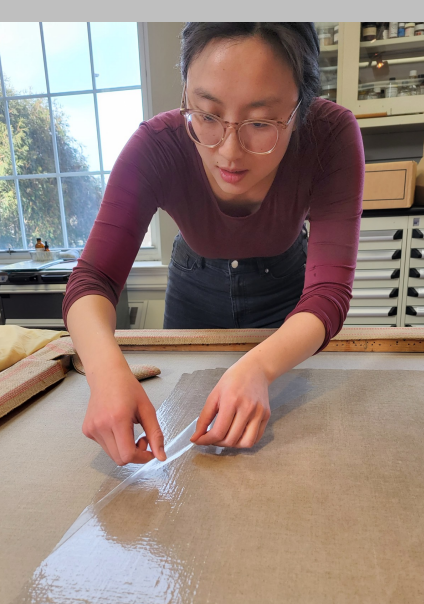
Fig. 19: Preparation of the lining canvas.

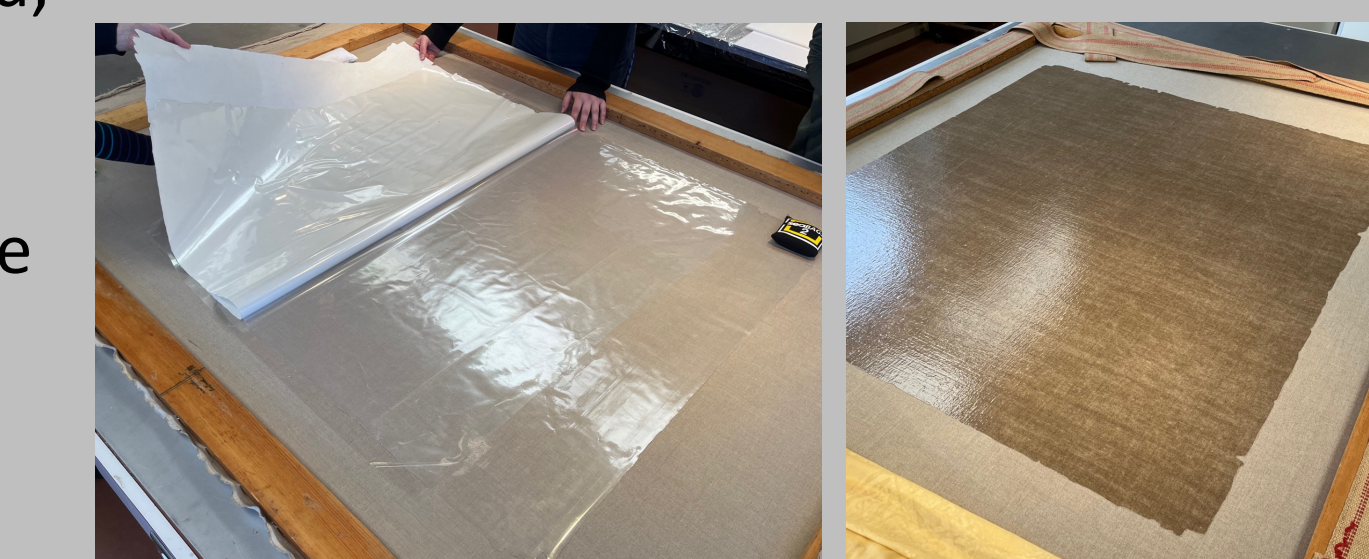
- higher activation temperature (~65-70°C) was needed for a secure bond, which may not be achievable or suitable for many paintings;
 - BEVA®371a film seemed less tacky at room temp than BEVA®371b;

- adhesion of lining was impacted by solvent exposure during initial brush varnish, resulting in pockets of separation occurring at interface of BEVA® 371a film and original canvas;

Figs. 20-21: One layer of 2.5 mil BEVA®371a on lining canvas before (left) and after (right) adhesion. Performed two rounds of heat and pressure on the vacuum table. Saturation occurred during second heating after increasing the temperature past 65°C to secure the first failed bond.

- re-heating of lining on hot table was needed to re-establish intended bond;
 - raised the question of logistics surrounding removability.
- Additional studies are needed for better understanding of temperature required for bond strengths, solubility, & removability. Practitioners should be aware of possible practical changes related to the re-formulation.

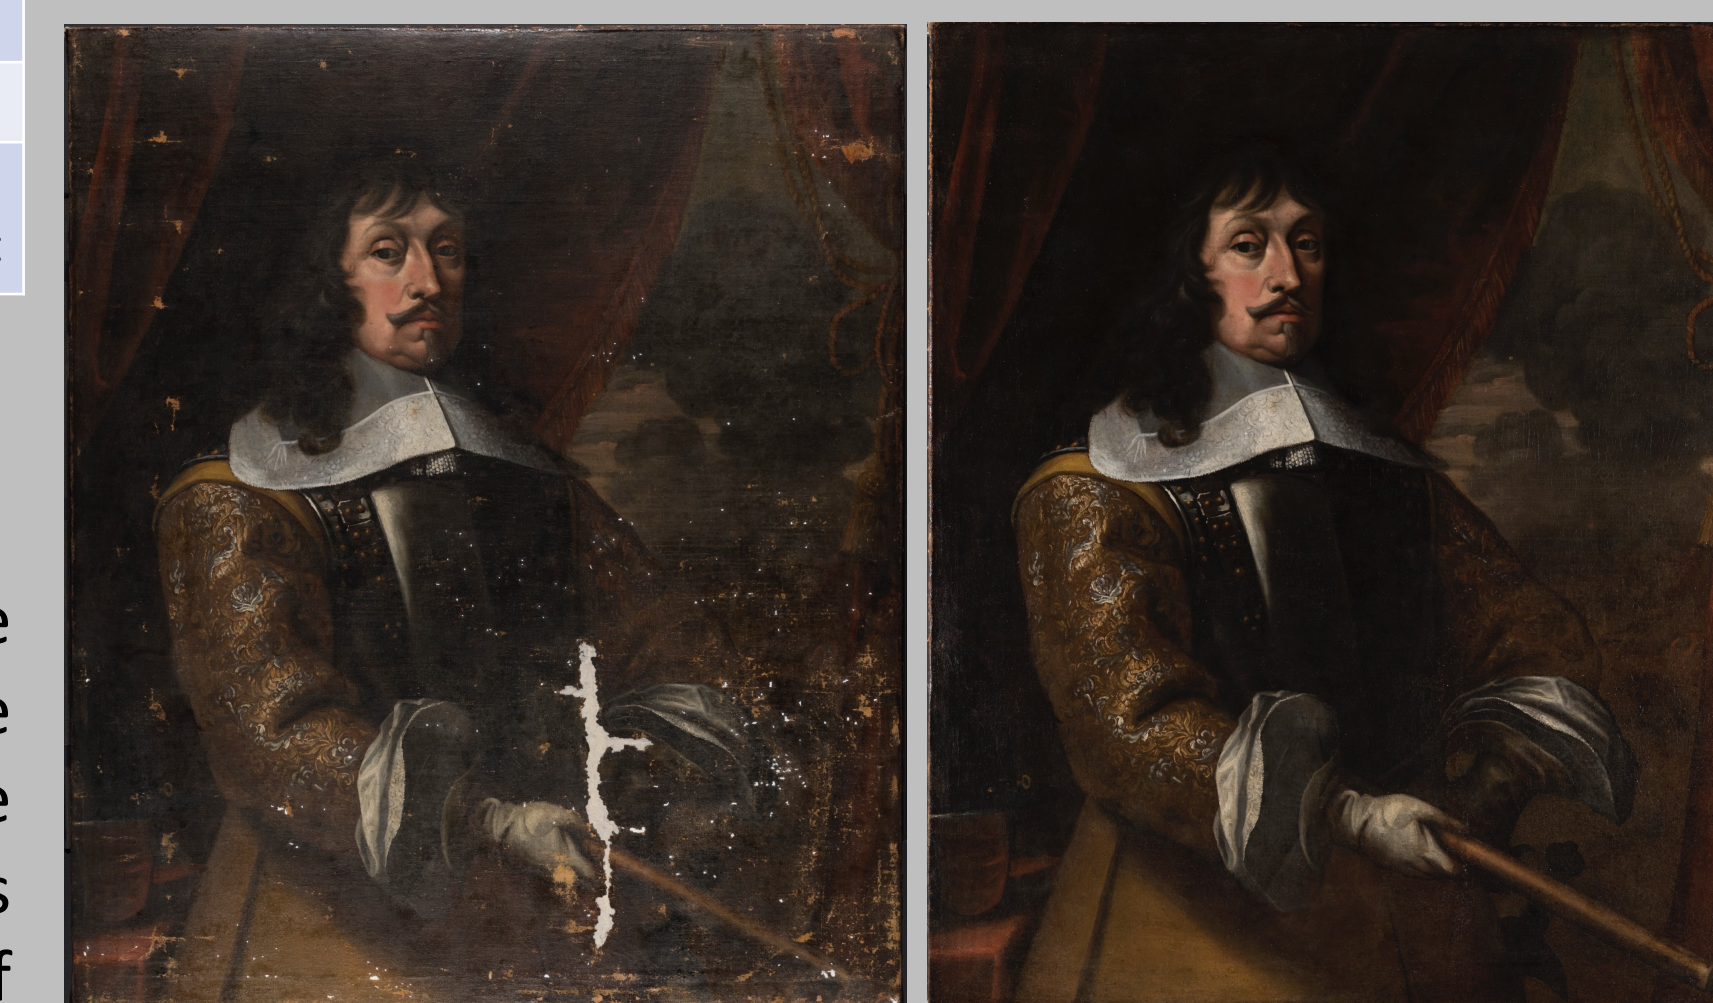
Figs. 22-23: Before inpainting (left) and after treatment (right).
