Objects Specialty Group Postprints

Volume Three

1995

Proceedings of the Objects Specialty Group Session
June 10, 1995
23rd Annual Meeting
American Institute for Conservation
St. Paul, Minnesota

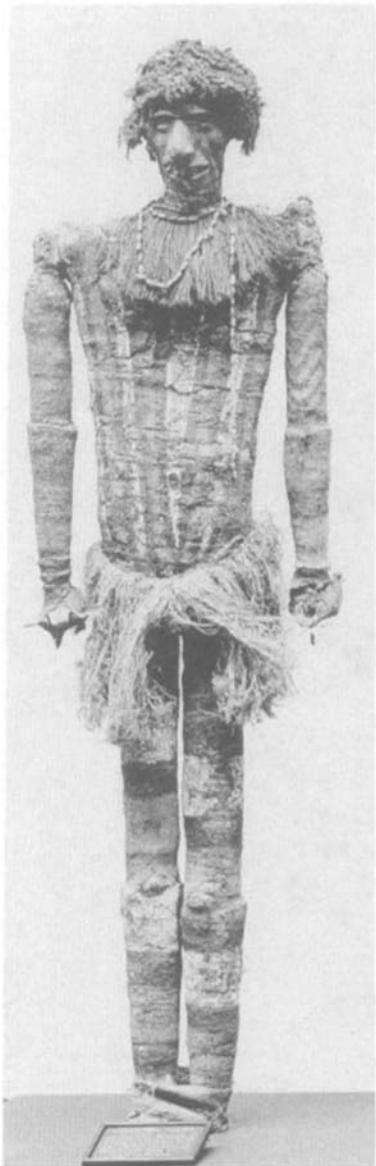
The overall condition of the figure was fair to poor. There were a number of structurally weak areas: both "hands" were only loosely connected to the arms, the head/neck attachment was insecure and unstable, and both of the arm/shoulder joints appeared to be unstable. These four unstable areas were, not surprisingly, those areas that were secured with vegetable fiber lashings. The vegetable paste layer in these areas was broken, damaged and coming apart. There was considerable movement in all of these areas, but nothing actually appeared to be in immediate danger of falling off. In fact, the movement of the arms had caused considerable damage to the pandanus leaves and vegetable paste on the proper right hip.

Figure 1. Rambaramp figure before treatment.

Having assessed the results of our examination, we decided that the figure required a well-designed mount that would fully support it, and that specific parts of the object needed support with separate brackets. Each hand required a bracket that would support it, along with the weight of the entire arm, so that the vegetable paste would not continue to fracture in those areas. The head and neck needed their own support, as did both legs. We also wanted to make a body cast for the object to support it in its entirety, since we felt that no matter how stable the artifact appeared at present, the materials that the figure was made from would not be able to support their own weight indefinitely.

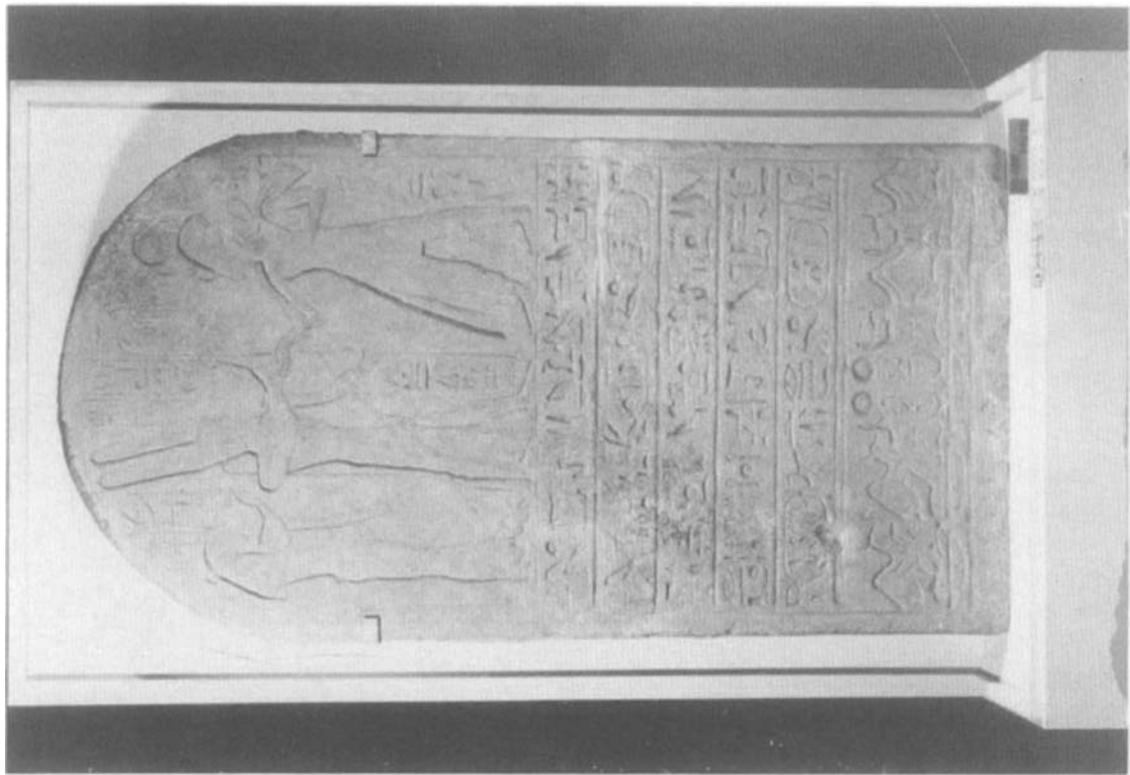
Figure 1. XIXth dynasty stela of Ramesses II,
front view, before treatment.

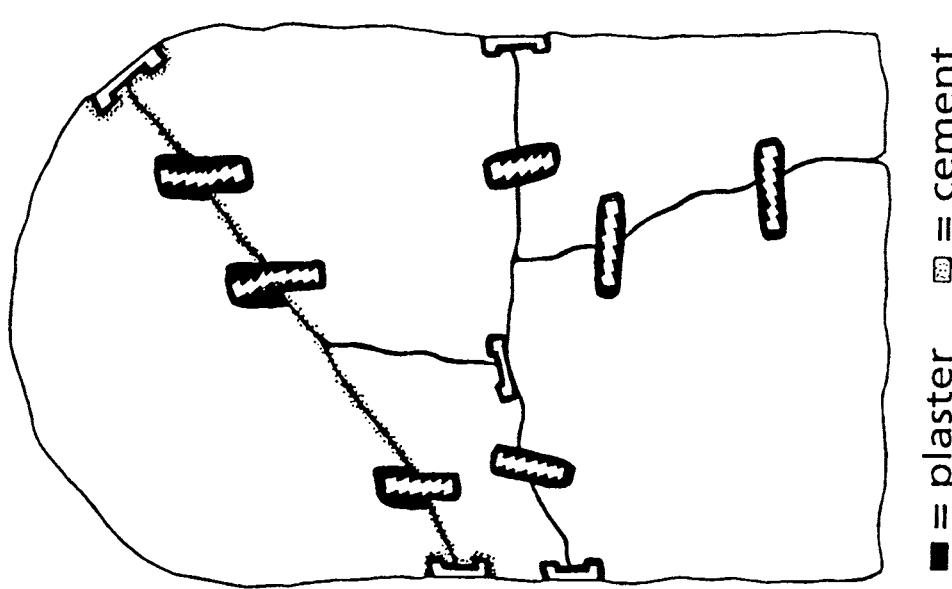
Figure 2. Diagram of stela, indicating location
of old repairs.

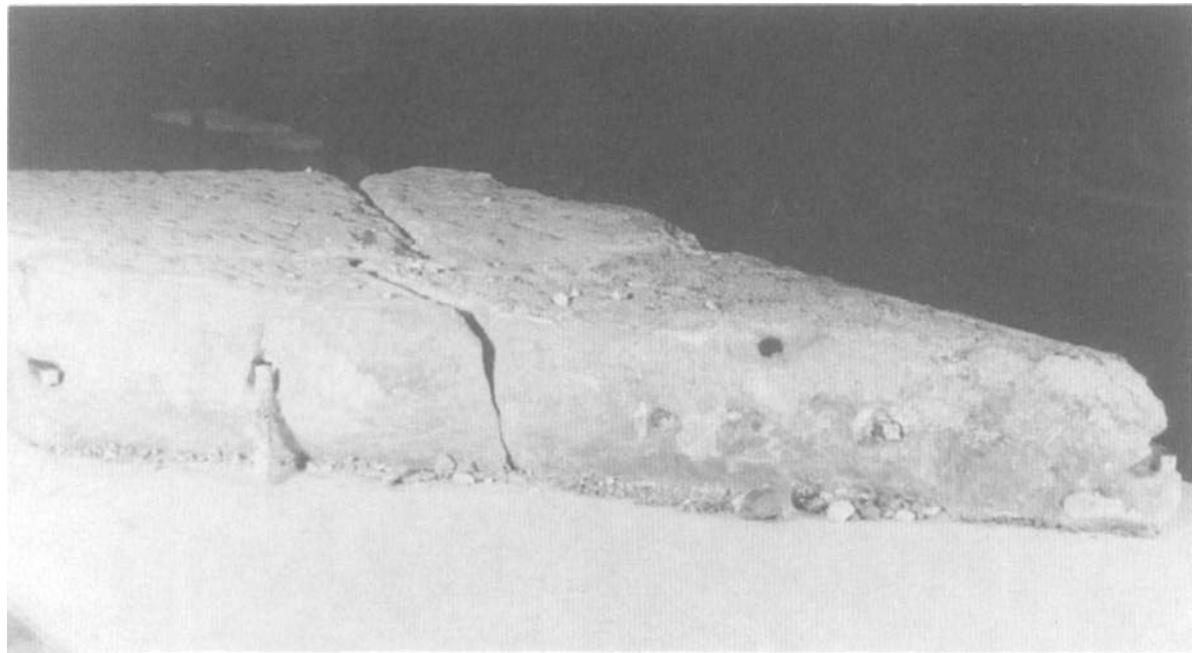
Figure 4. Stela, during treatment. The top, curved fragment is removed revealing notched copper dowels and staples used in the previous repair.

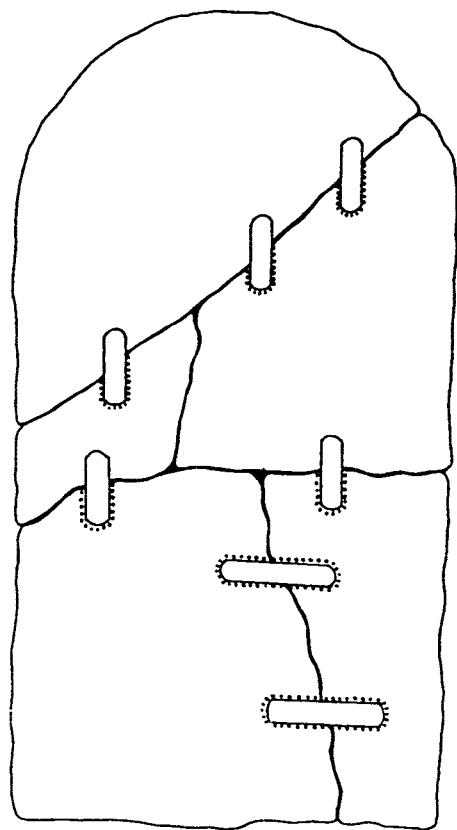
Figure 7. Diagram of stela indicating location
of new dowels and application of adhesive.

□ = application of B-72
+ fumed silica between
dowel and sleeve

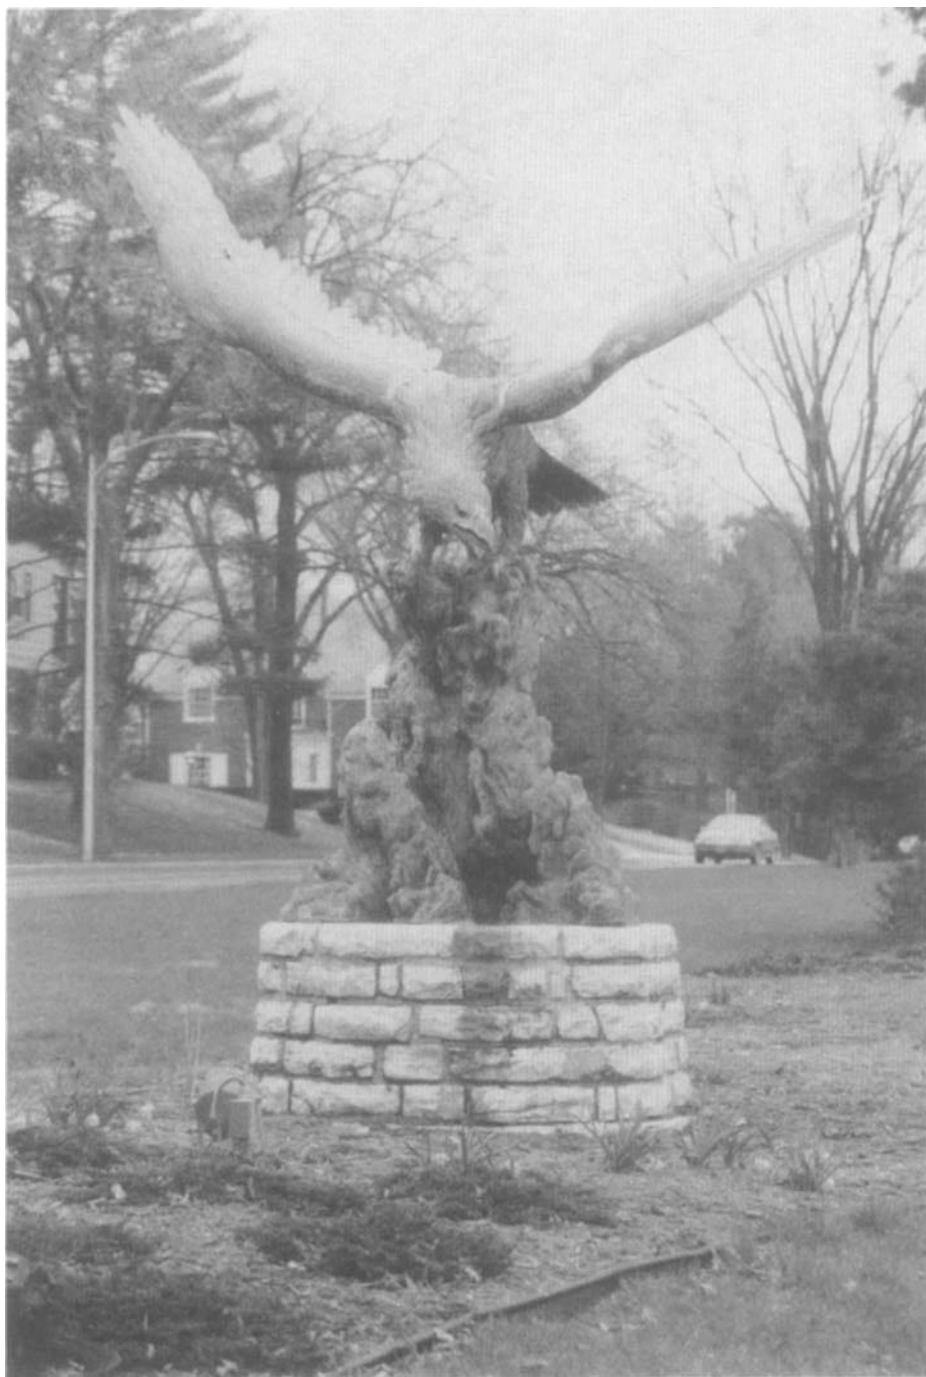
Figure 1. General view of sculpture *in situ*, before treatment.

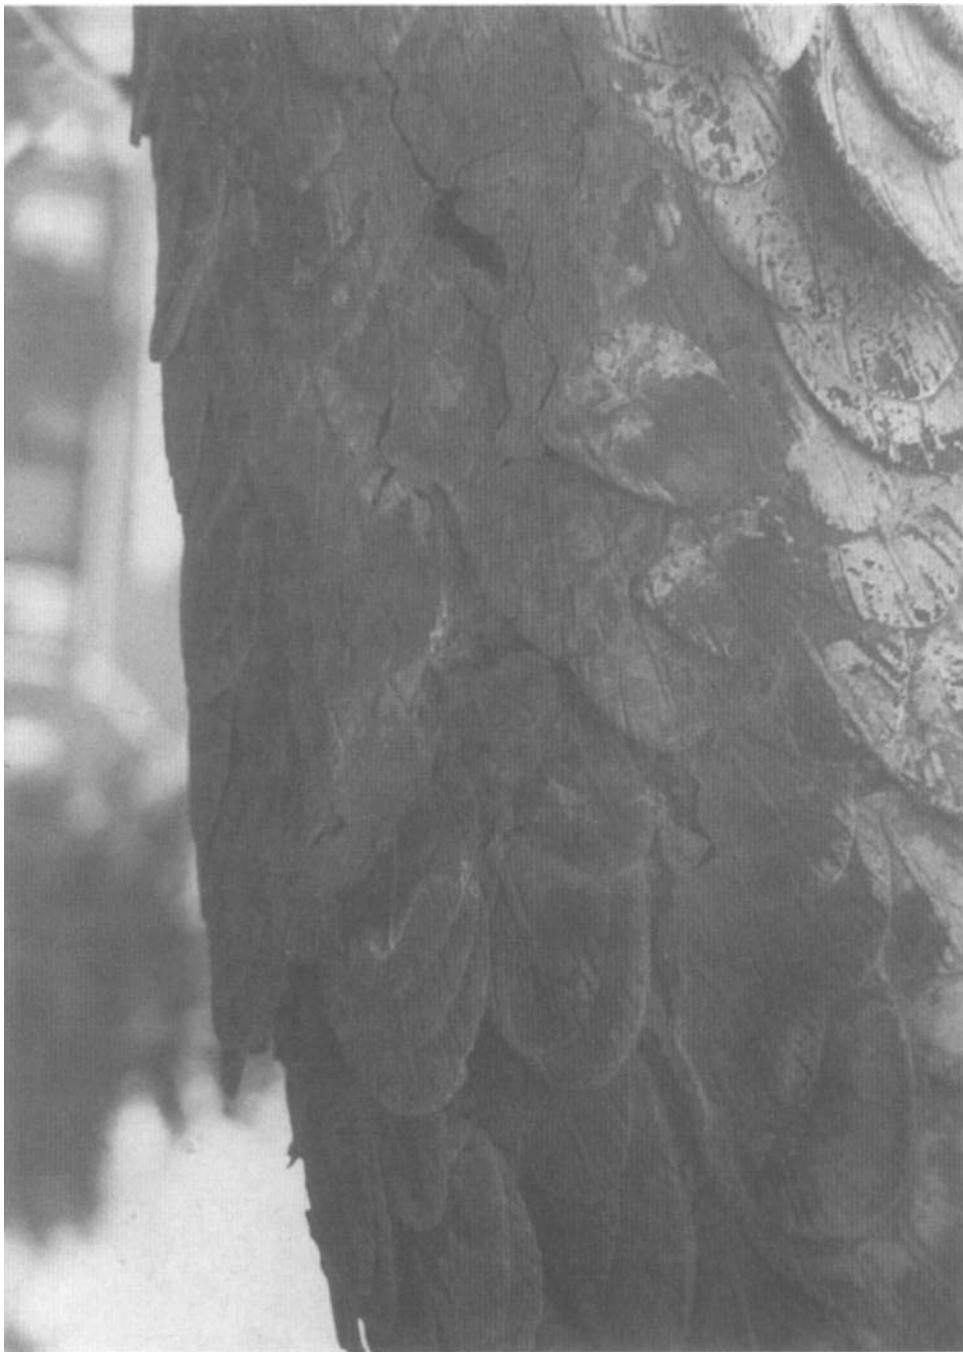
Figure 2. Detail of proper left side of neck, showing the extensive cracking and breaking of bronze due to ice formation. The concrete used in the 1935 repair is visible on the interior of the neck.

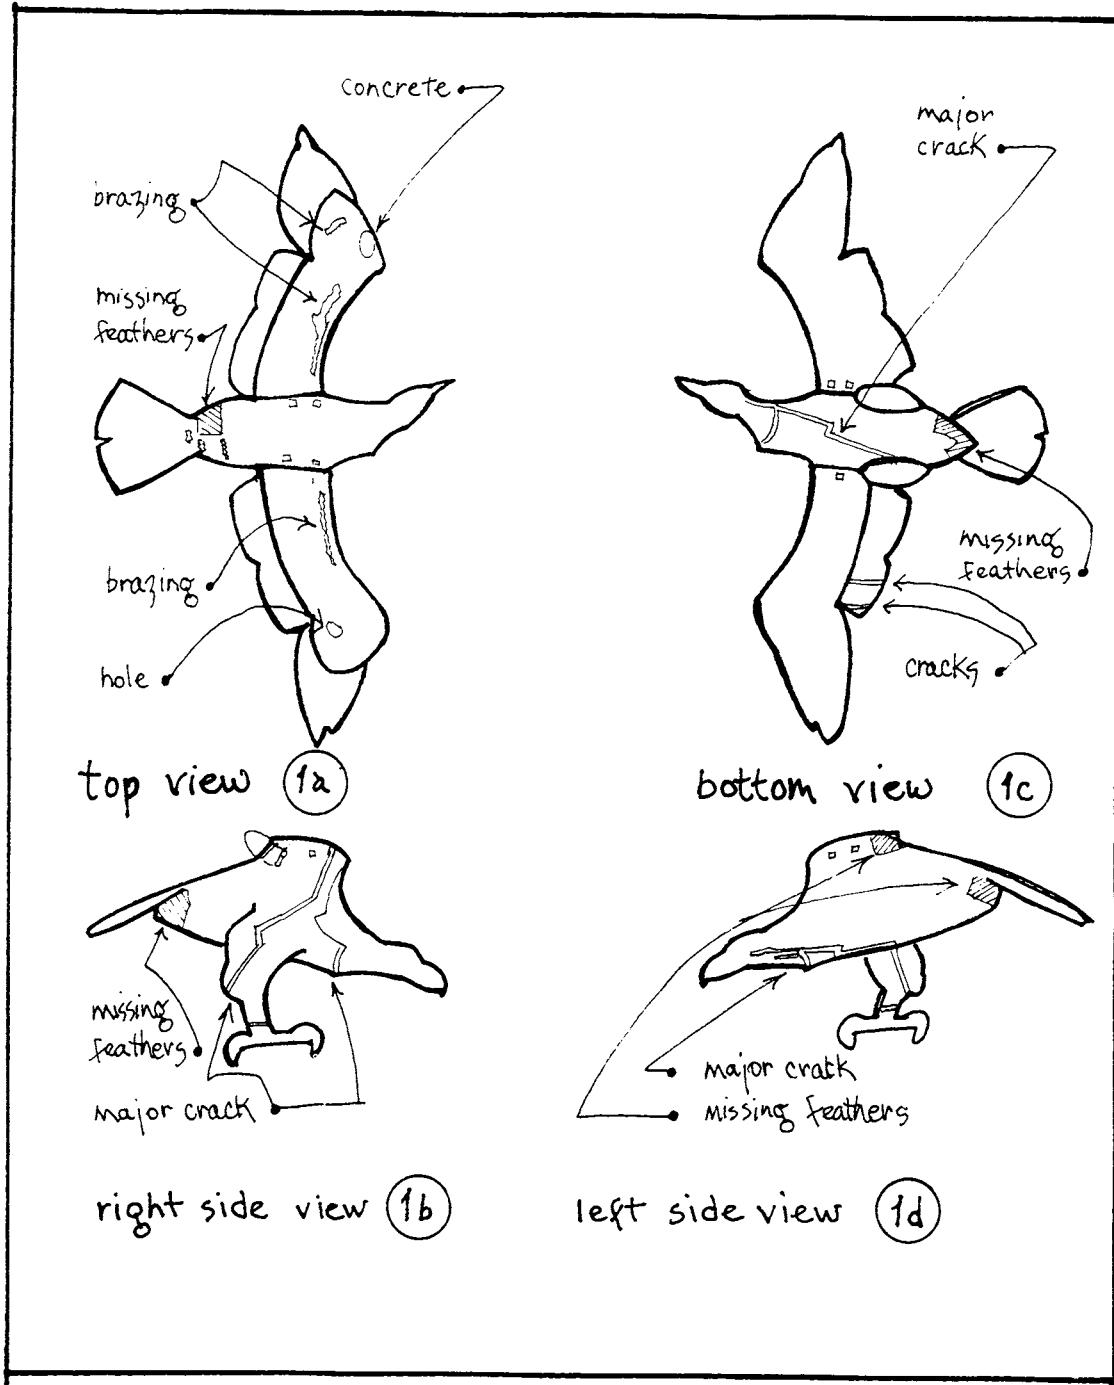
Figure 3. Diagram used in our initial Examination Report and Treatment Proposal (April 2, 1990), showing the crack systems and other damages to the eagle.

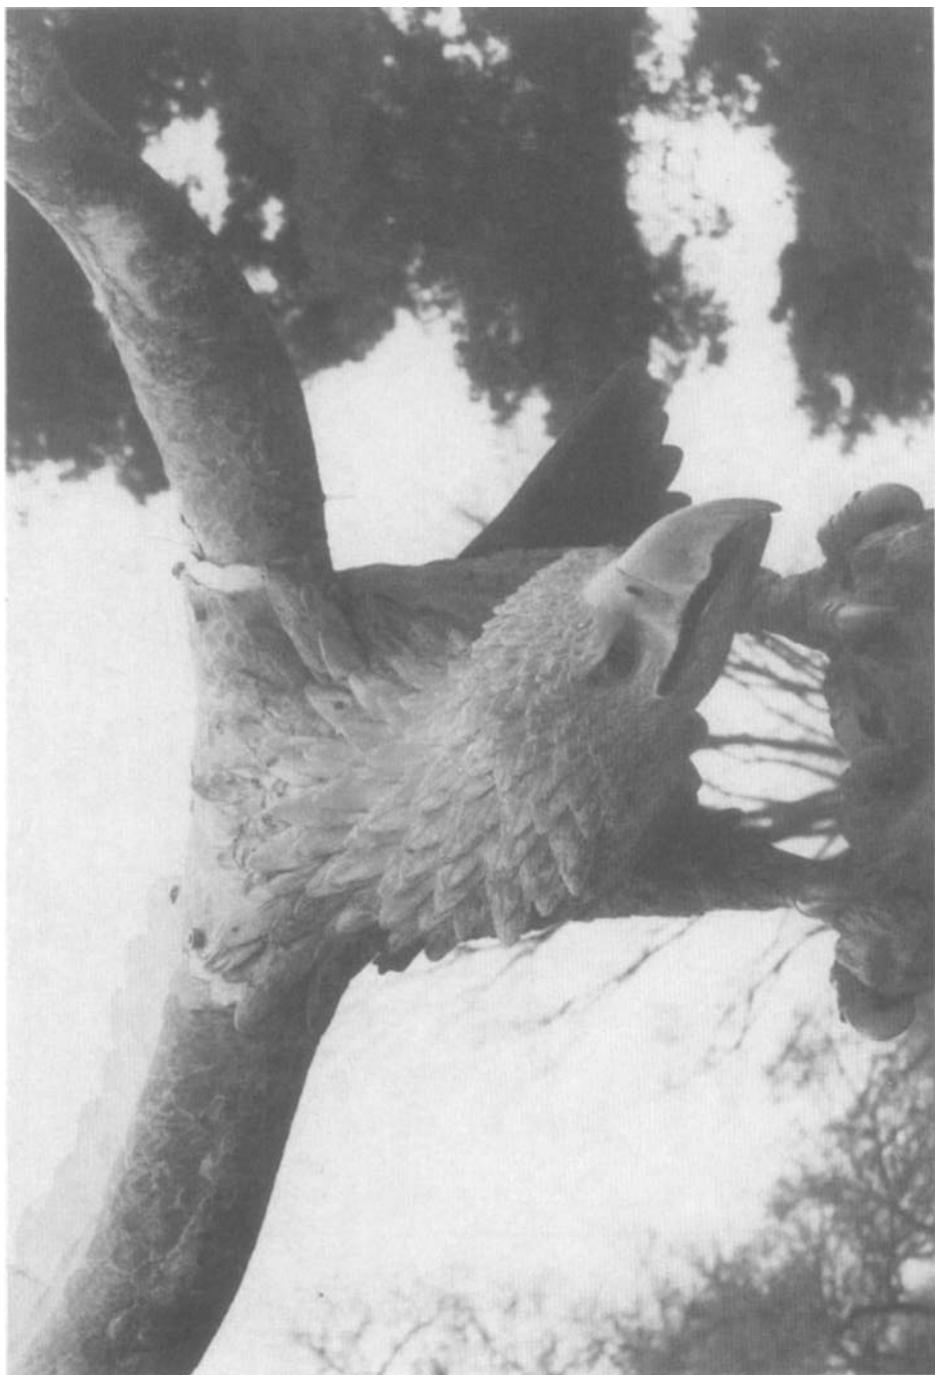
Figure 4. Detail, front view of eagle before treatment. Note the large bolts at the shoulders, and the icicle hanging from the proper left wing. The eye insert is also damaged and incomplete.

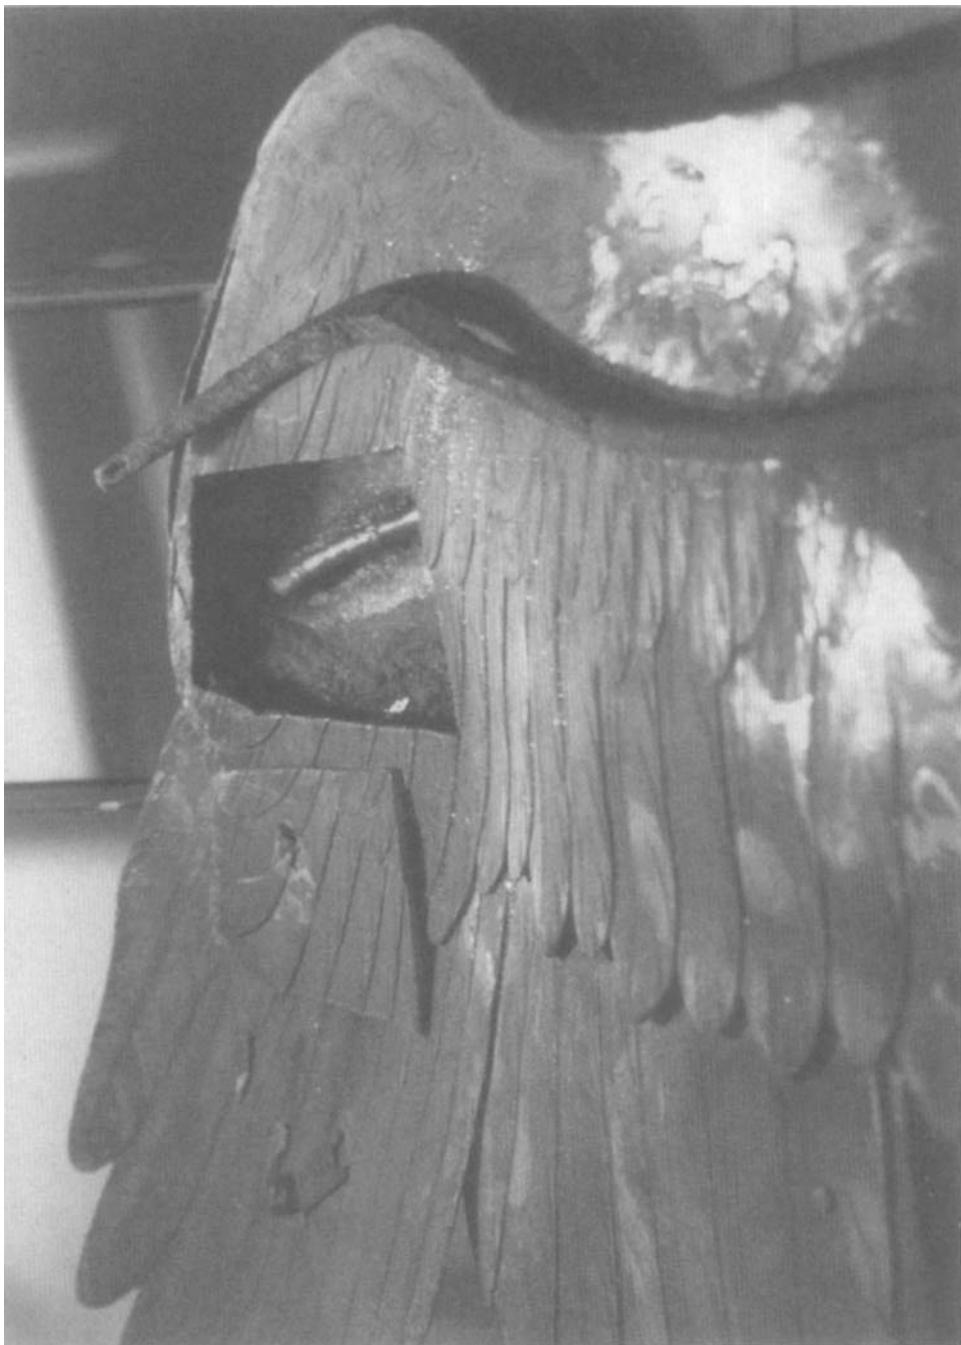
Figure 12. Detail of wing with access panel cut out. The original wrought iron armature is shown lying on the outside of the wing. The new wing armature is visible on the interior, welded at one end, in the same location as the previous armature.

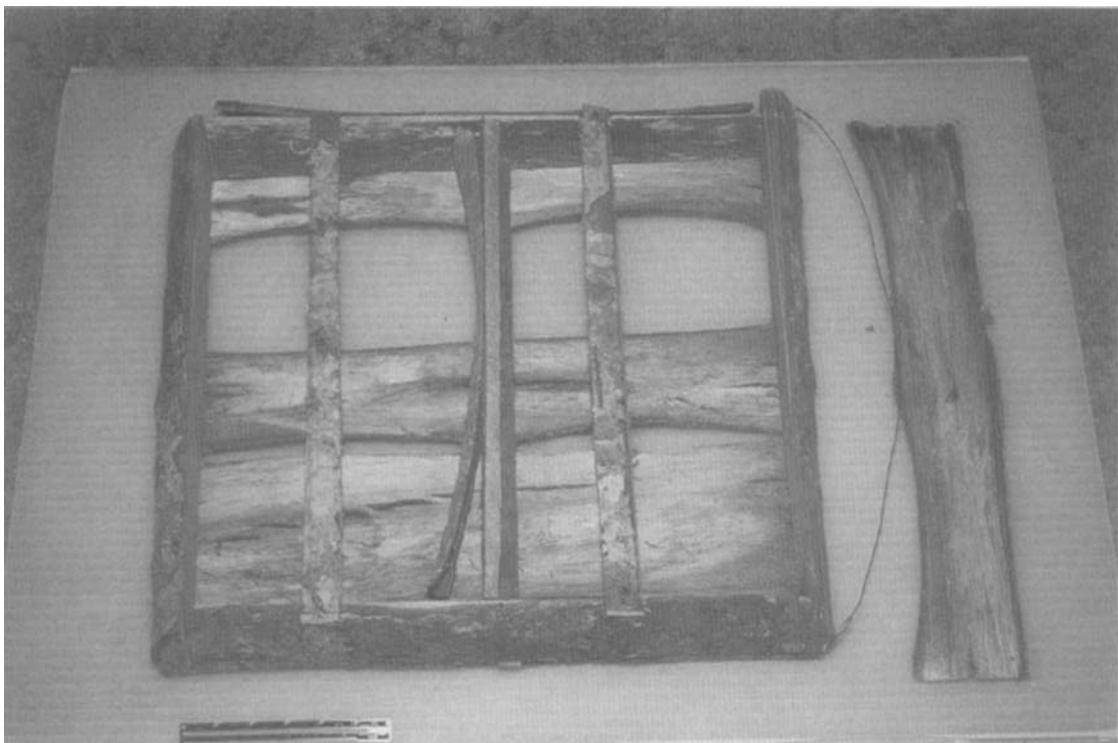
Figure 2. The rack before treatment, showing the warped back.

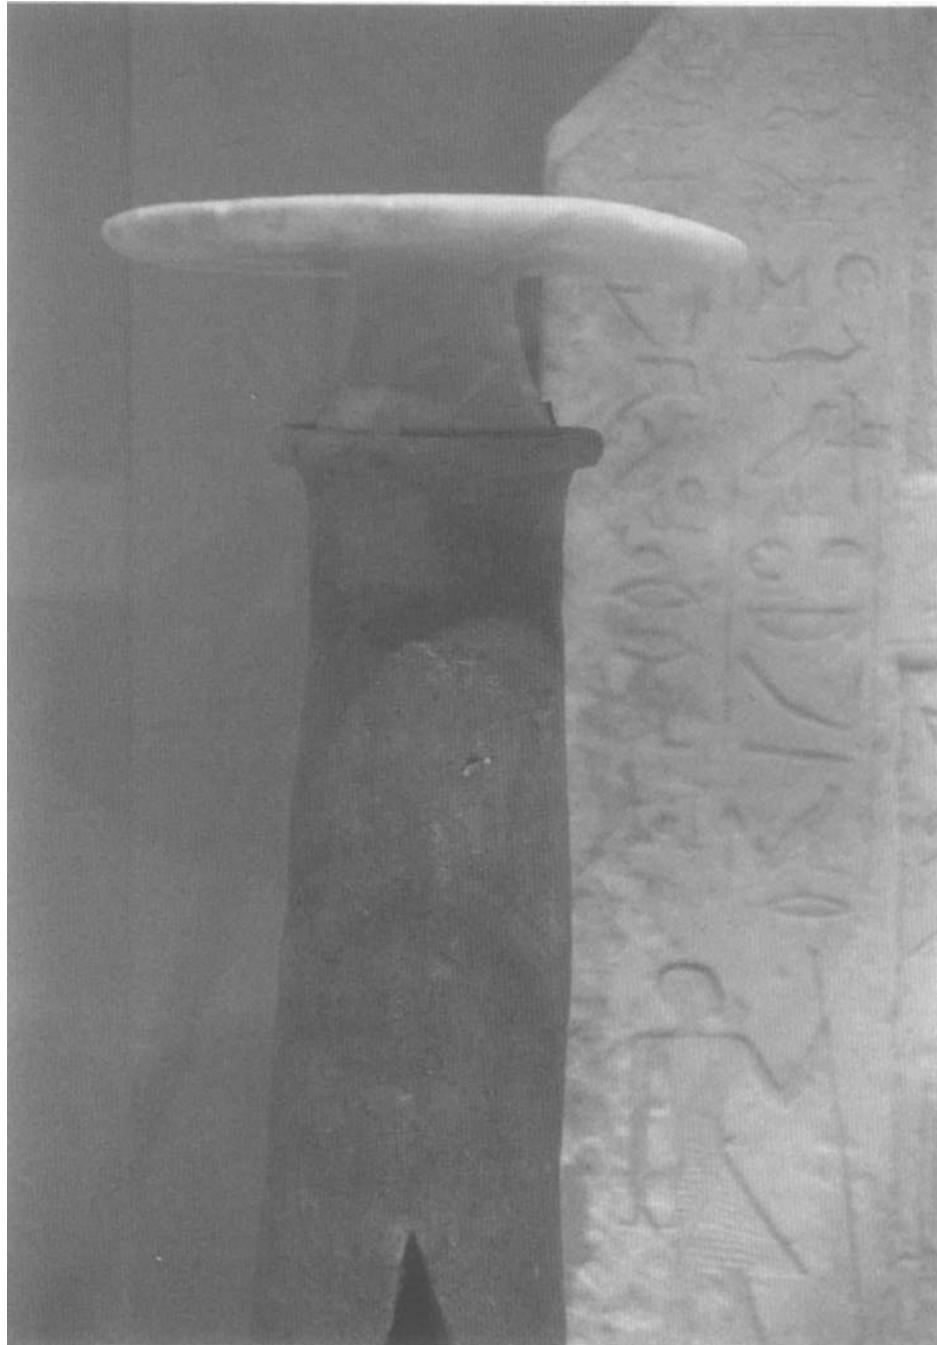
Figure 13. Offering table on its pottery stand (MFA 11.2394) in the Museum's galleries in August 1995. Note the sagging right side of the table.

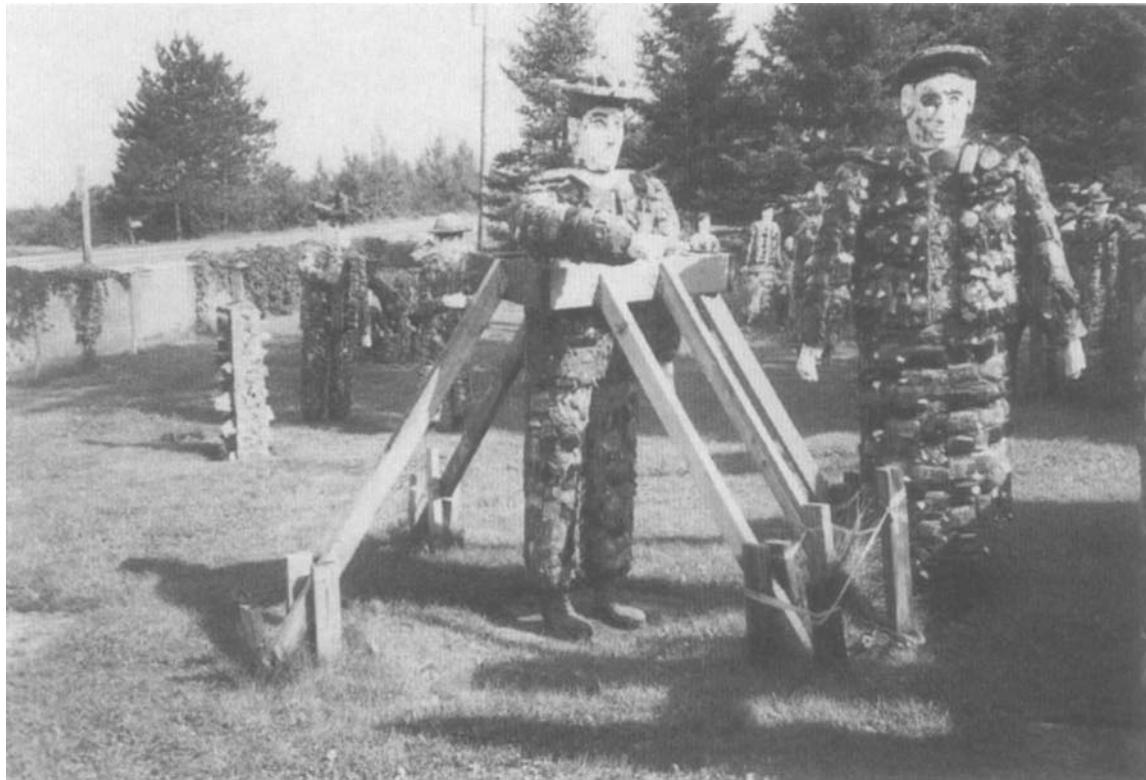
Figure 3. Wisconsin Concrete Park. Wooden braces support a weakening sculpture.

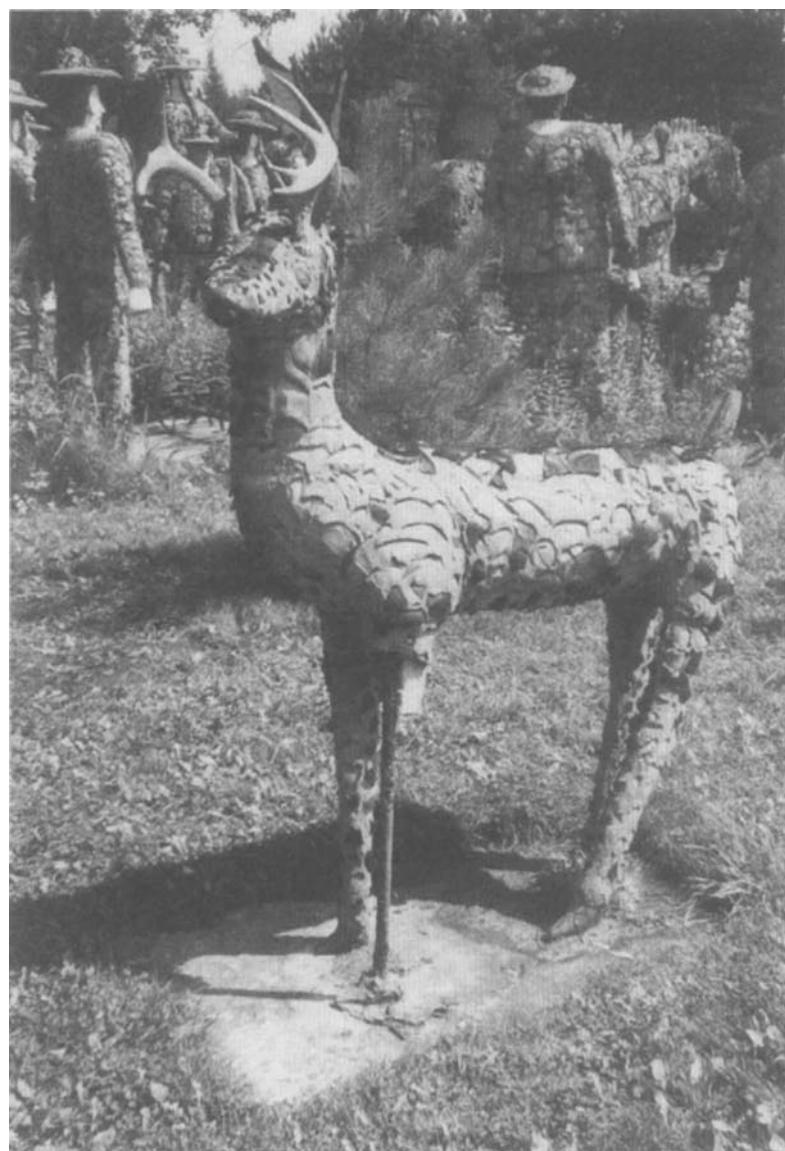
Figure 4. Wisconsin Concrete Park. Corroding iron armature has led to the deterioration of the concrete veneer.
