HAITI CULTURAL RECOVERY PROJECT
INSPECTING A ONE OF THE DAMAGED HECTOR HIPPOLITE PAINTING
AT THE NADER GALLERY

Smithsonian/AIC/Blue Shield Mission to Port-au-Prince, Haiti AIC-CERT Member Hitoshi Kimura

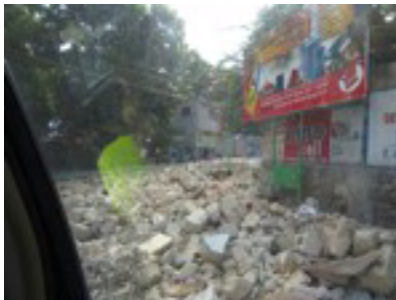
In some area, building debris narrows the street

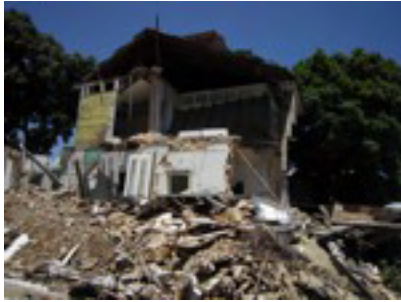
Damaged Center D'Art building

Center D'Art needs to be cleaned of debris. I feel through the cleaning process they might find some important object under the debris and it would be better to do this before getting more rain.

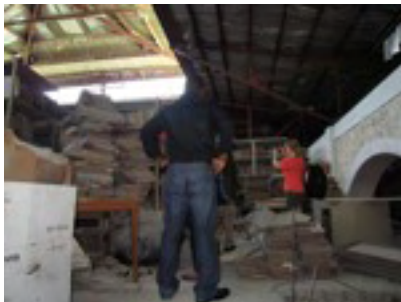
The building of the National Archive seems sound but roof structure has been partially damaged

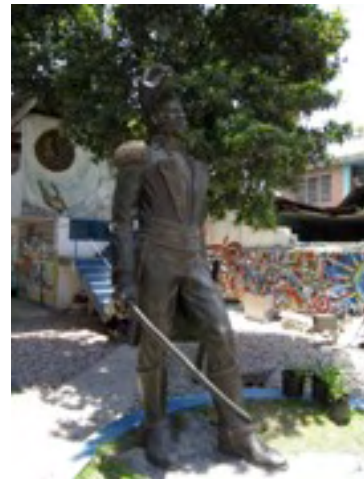
We saw many people were living under the tents at the campus of the Ecole Nationale Des Arts. However we didn't see any collection damage.

Ecole Nationale De Arts's small campus was filled with tent and many people was living there. We saw people were busy fixing the damaged part of building and some performing art students were practicing singing along with play drums. We didn't have a representative from this institution at the time of our visit and difficult to understand the scale of damage to this institution. It will be more effective if we could meet representative from each institution during our visit.

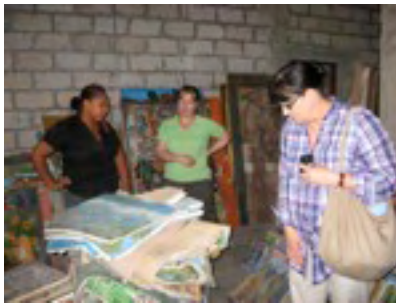
Over 3000 damaged painting is store at third floor of building

At the time of our arrival, entire third floor was filled with strong smell of chemical fumes. It was a typical lacquer paint smell and possibly came from many empty cans piled up on the side of room used for frame works. Entire storage room does not have climate control and most paintings were piled on top of each other. There is need for vertical storage shelving and and also education about health issues in dealing with chemicals. This location is the only place to store collection under roof. They are also using second floor for storage which has climate control.

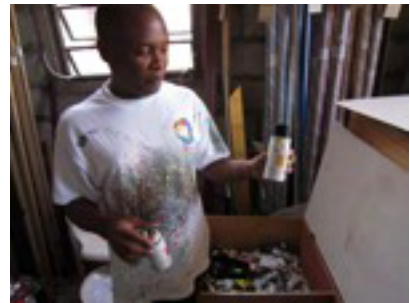
Young man works as a restorer at Nader Gallery showing his art supplies

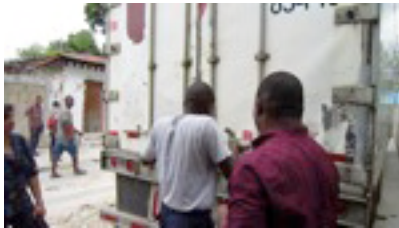
Container's exterior wall temperature was 108 F and interior roof temperature was 105 F. The temperature inside container was 108 F which was creating an oven effect. Inside temperature drop immediately to 98 F when door was opened, circulating fresh air.

There is a power line hanging directly above the container but power has been dead since after the shock

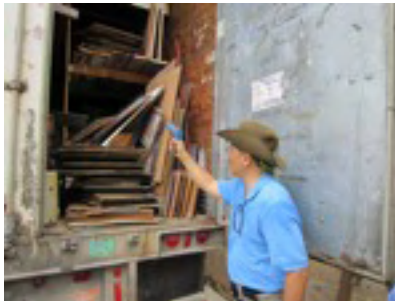
measuring inside temperature

Also, we measured the inside temperature of container at 108 F which was creating a oven effect on all objects inside, possibly damaging more painted surfaces of the objects. One of the biggest problem with this institution is that they no longer possess any facility to bring back treated objects. I would urge them to start taking their damaged collection back to their or some facility because of mold growth damage. The director of the institution told us that they are getting four new smaller containers on site to replaced two large container in near future for storage. The Haitian art movement was started by the help of American artist Dewitt Peters in 1944 who established the art school Le Center D'Art. This institution is a bridge between our two nations therefore their collection has a significant historical and cultural value.

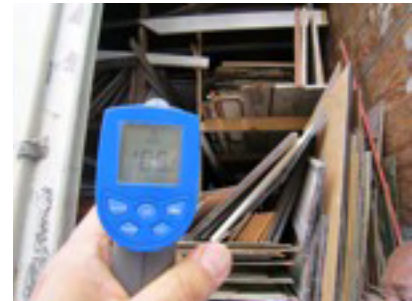
inside roof temperature was 105 F

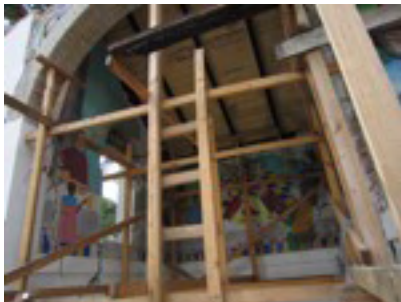
The largest surviving image is the Last Supper scene; however, right above the image the roof hasn't been covered by tarp and shows some water mark on the surface of painting. Also, the condition of ground is unstable, many fresh cracks have opened on the wall and appear ready to fall down. The Smithsonian's structural engineer has checked damaged structure but currently inappropriate wooden braces have been placed in which don't support fallen wall structure.

Wooden beam is just supporting archway and not the mural image wall

Need to stabilize concrete wall structure to stop further deterioration of painting images. All images start at 8 feet up from ground and I would suggest to build platform at same level to reduced impact damage in case more sections of wall fall down until proper treatment. Also, definitely need to cover the roof by tarp to avoid more water damage. The tin roof is probably creating more acidic water damage to surface of mural images. All fallen mural images need to be collected and catalogued by location and subject and then stored inside of building with climate control.

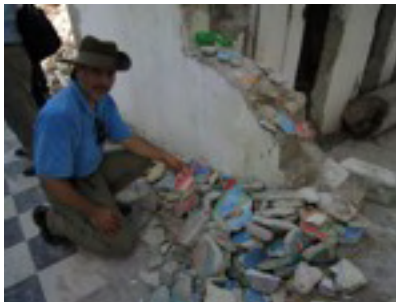
Many fallen images are not collected appropriately and still on the open ground

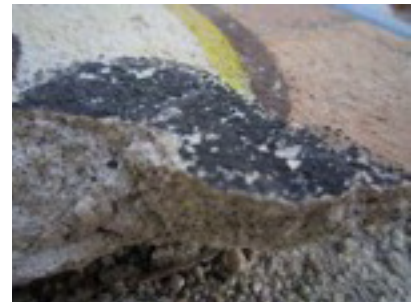
Section of fallen wall shows how thin the original paint was applied directly to the concrete wall

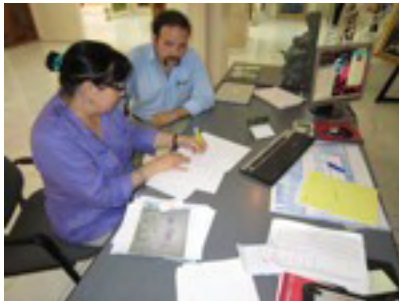
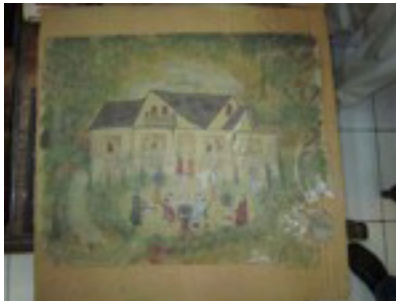
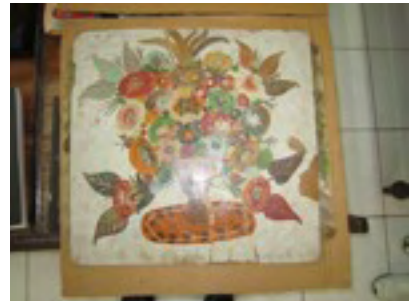
Started day by writing a condition report for three paintings. The Smithsonian's collection manager Gail Joice was leaving Haiti by noon flight, so I wrote three quick painting examination reports which include Celestin Faustin and two paintings done by Carlo Jean Jacques. Two of the remaining paintings were done by one of the important Haitian artist Hector Hippolite so I decided not to touch his painting with the limited time schedule and passed on to next conservator for fresh start. Also I found out that none of the staff members at the office are working on Sunday and it is difficult to hold our driver for a day. So I had a only about four hours to work on the painting and focus on the one painting done by the Celestin Faustin" in order to accomplish best work.

Treatment started by vacuuming the surface with speed control vacuum cleaner with micro tip brush followed by consolidation of damaged surface and tear mending methods from reverse. Filling the damaged area was done but time ran out for proper inpaint.

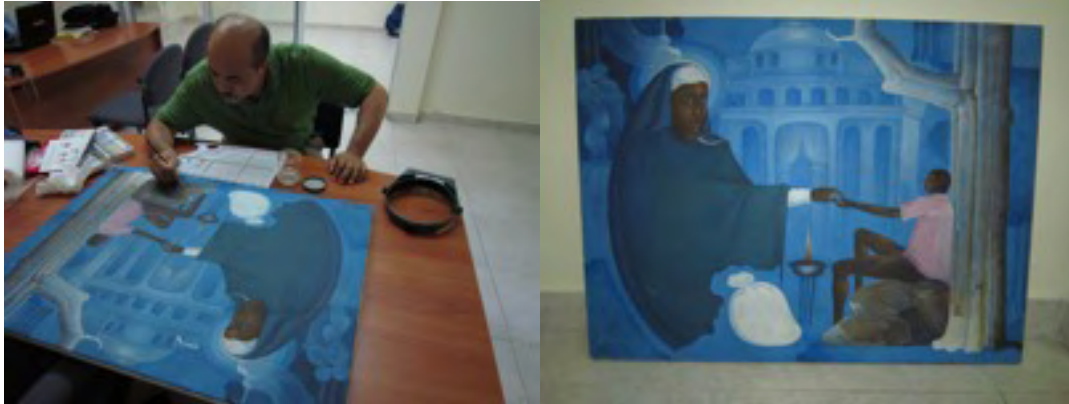
My last day in Haiti and my flight was schedule to leave at noon, so leave for the airport early to ensure no traffic delays on the way. Arrived at the center with other team members in the morning and had about one hour left to work on the painting's inpaint then heading to the air port with U.S. Blue Shield president Cornine Weggner. She was supposed to be pick up Center's new director Stephanie Hornbeck at the air port coming from Miami around same time of my departure.

The painting above is dated 1981 which is the same year of artist's death and subject is the artist himself reaching out to a voodoo goddess Erzulie Dantor. This was completed near his death so he may have had a glimpse of his success. Following is his biography:

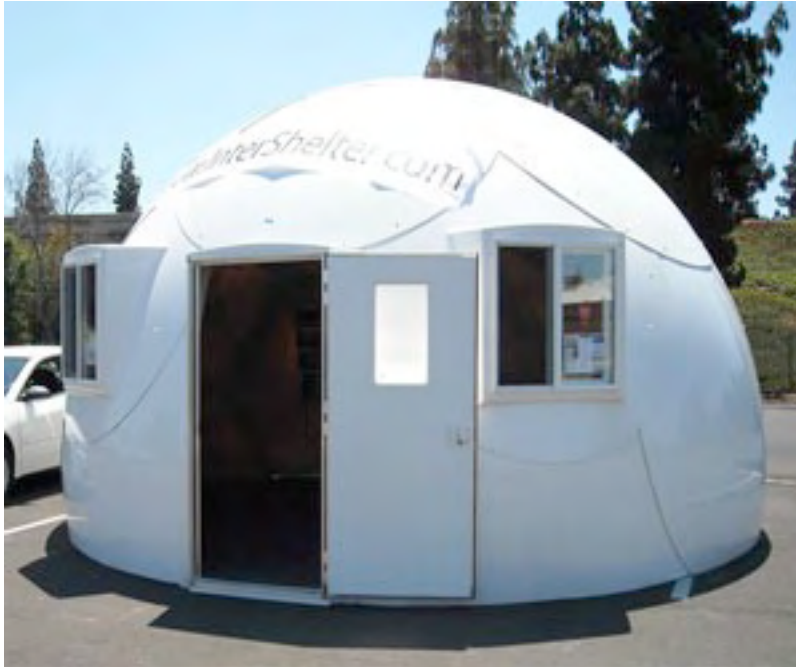
The Intershelter Dome is a temporary housing structure that resembles a modern-type of igloo. The domes, which are available in a 14-foot model for \$7,500 and a 20-foot model for \$12,500, can provide shelter to between two and six people. The domes are made out of an aerospace composite material and can withstand hurricane force winds, as well as earthquakes. Arctic and desert models are also available.

According to Intershelter President and CEO Capt. Don Kubley, the domes can be put together by three people in about two hours. Intershelter Domes have been deployed in 15 countries thus far, Kubley said. In the U.S., they have been deployed in California, Oregon, Washington, Michigan, New York, and Louisiana. As with some of the aforementioned shelters, the Intershelter Dome not only serves as disaster relief housing, but can also be used for a wide variety of other applications including migrant workers, military housing, hunting camps, the homeless communities, and quarantine shelters.

In addition, I did some research for possible portable storage shelter for Le Center D'Art and came a cross a product. This company already send their product to Haiti and two of their representatives are still in Port Au Prince.
