Objects Specialty Group Postprints

Volume Three

1995

Proceedings of the Objects Specialty Group Session
June 10, 1995
23rd Annual Meeting
American Institute for Conservation
St. Paul, Minnesota

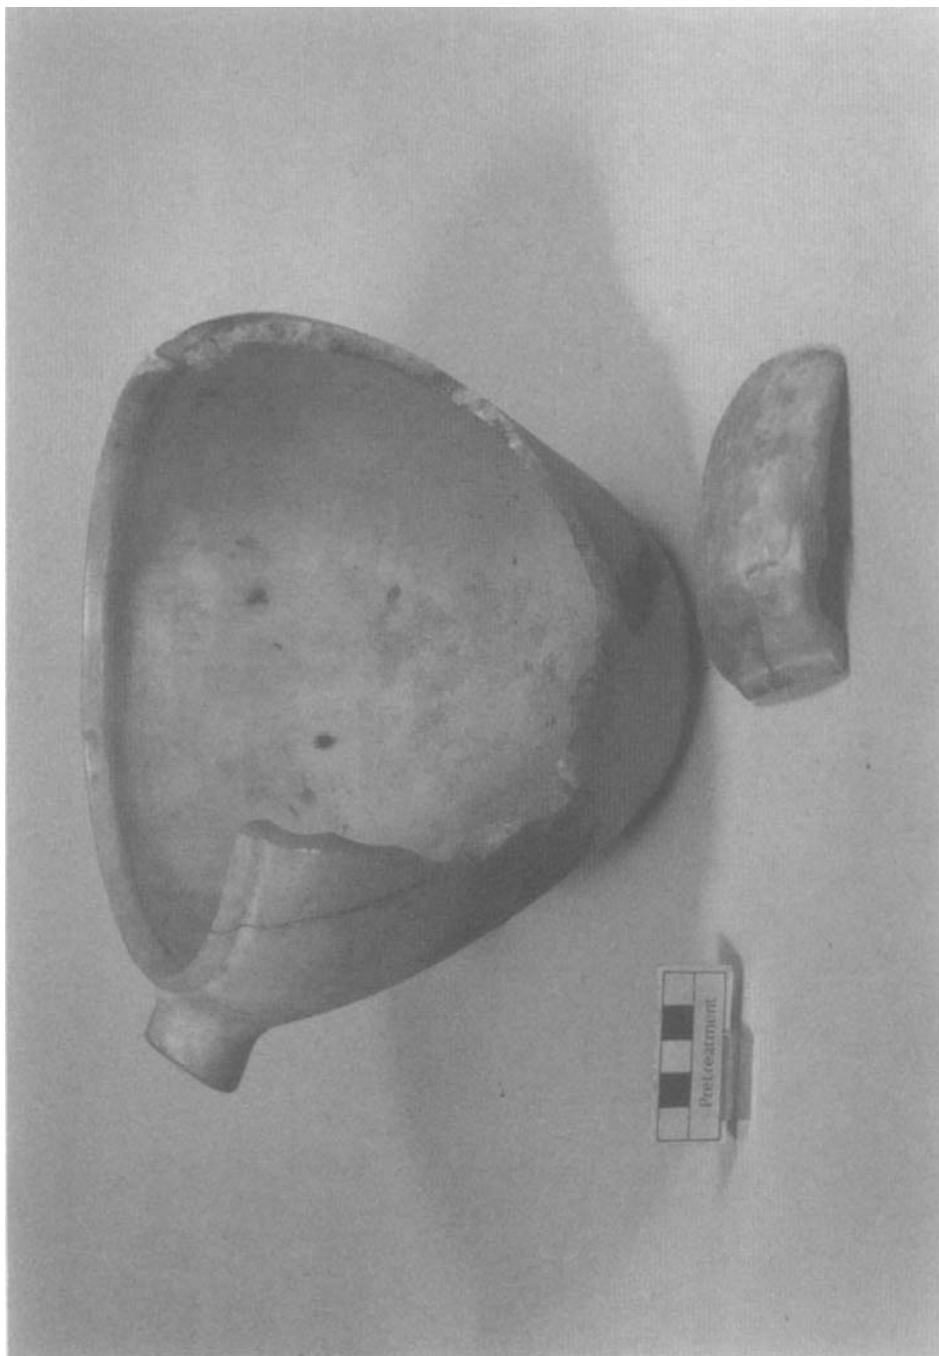
(Figure 5). It was broken in two pieces, and had a loss at one side of the vessel. Sticks and sheets of the fill material, colored to match the base color of the jar, were melted against the primed break edges after cleaning. As the material cooled slowly, more layers were added and the fill was smoothed with a heated spatula. It was easiest to overfill and continue final shaping mechanically. The wax-resin was sanded, and buffed and polished with a cotton cloth and Novus Plastic Polish No. 2 to match the surface luster of the original stone (Figure 6).¹² A high gloss can be obtained by polishing a fill that has been made scratch free by sanding with increasingly fine sand papers. Full compensation of the loss was required using acrylic emulsion paint to continue a dark stain and some superficial white spots from the original surface (Figure 7).

Figure 5. Old Kingdom spouted bowl (MFA 72.557) before treatment.

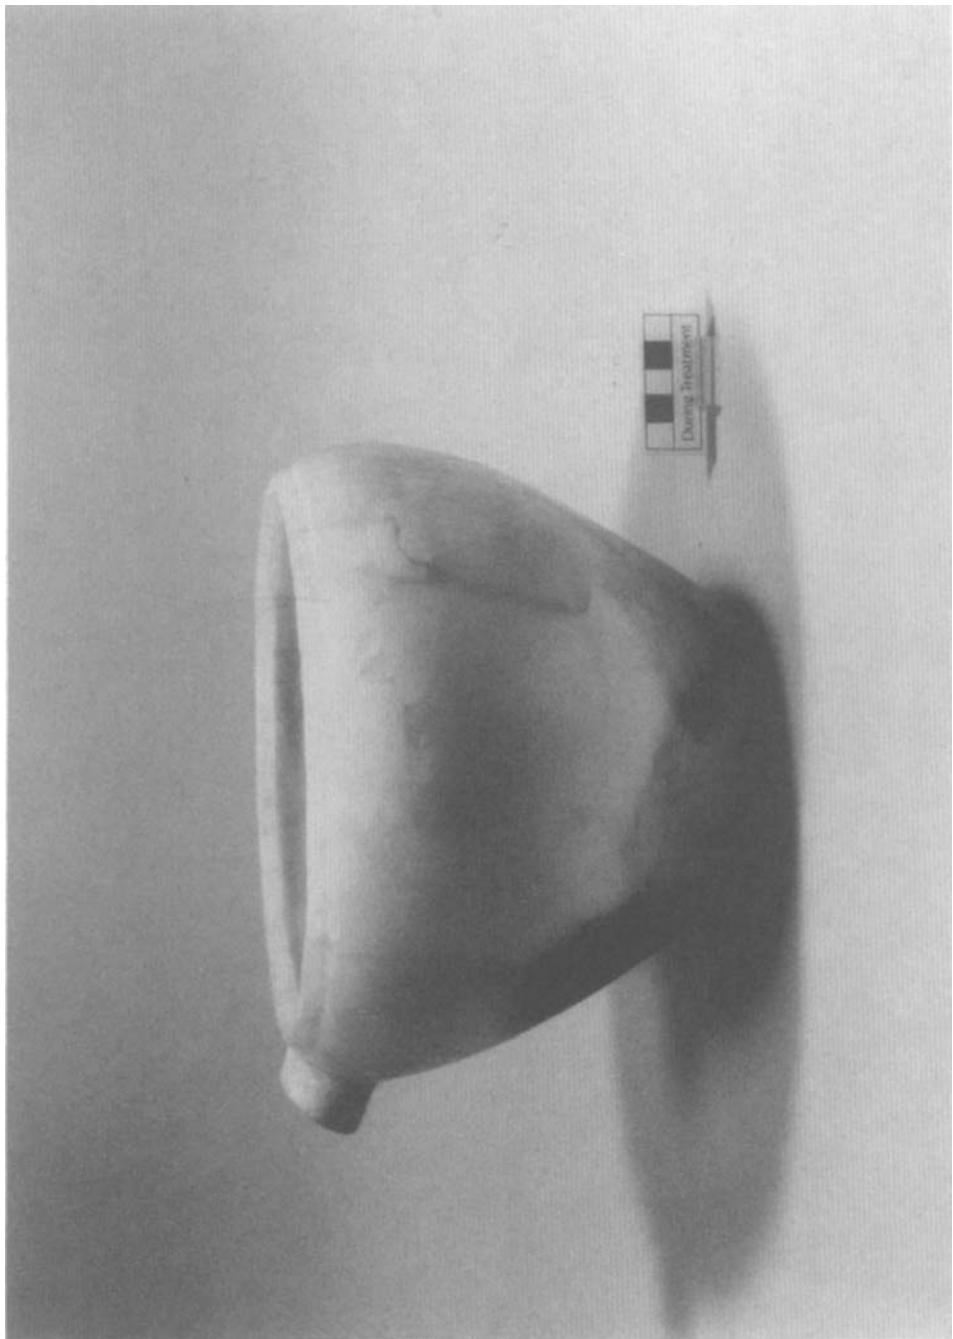
Figure 6. Wax-resin fill in bowl (MFA 72.557) prior to inpainting.

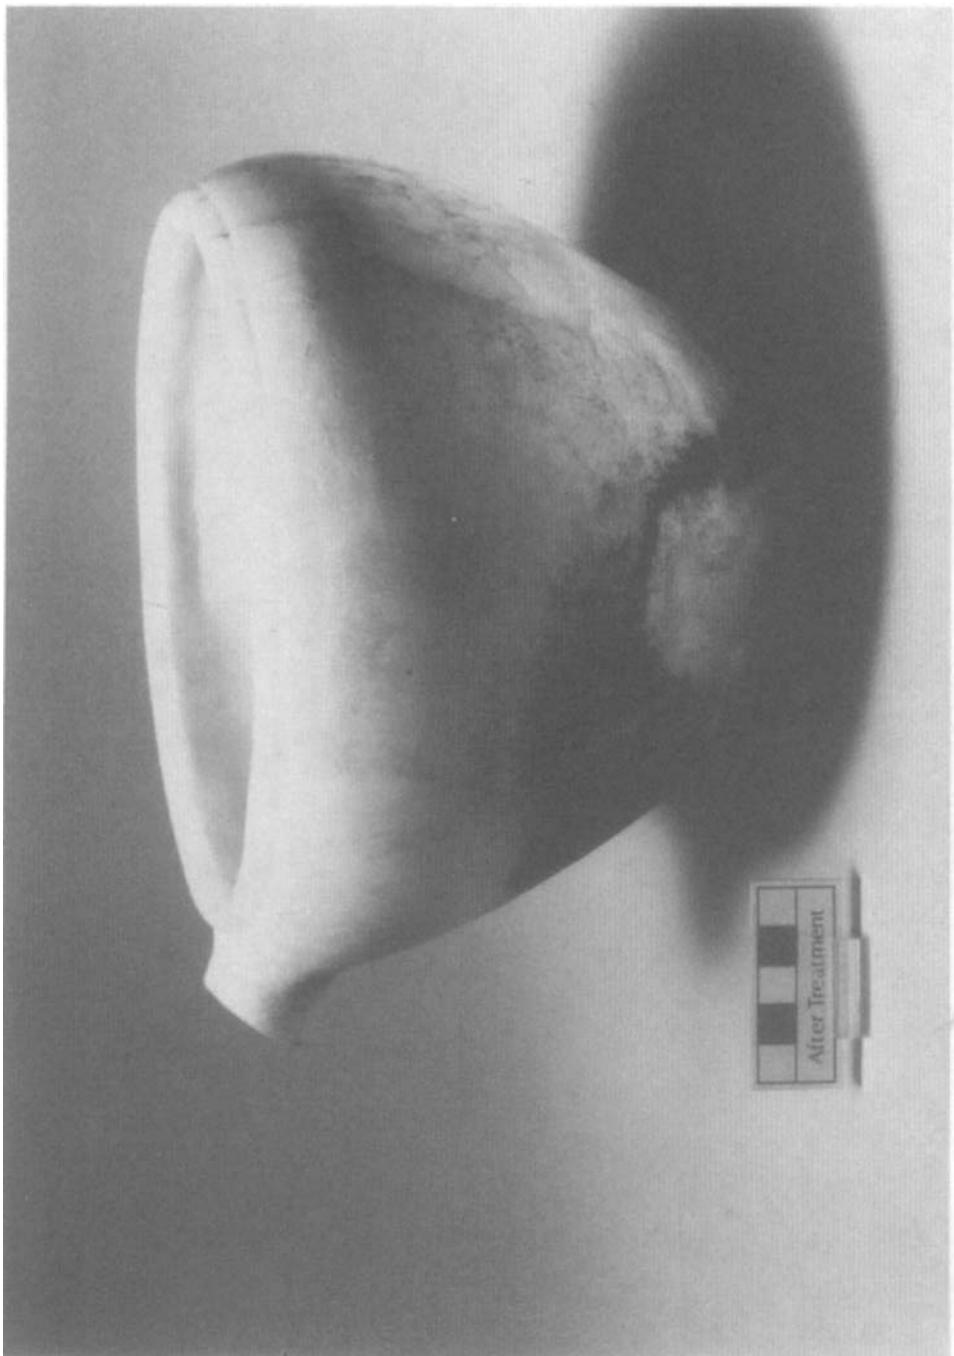
Figure 7. Bowl (MFA 72.557) after polishing and inpainting.

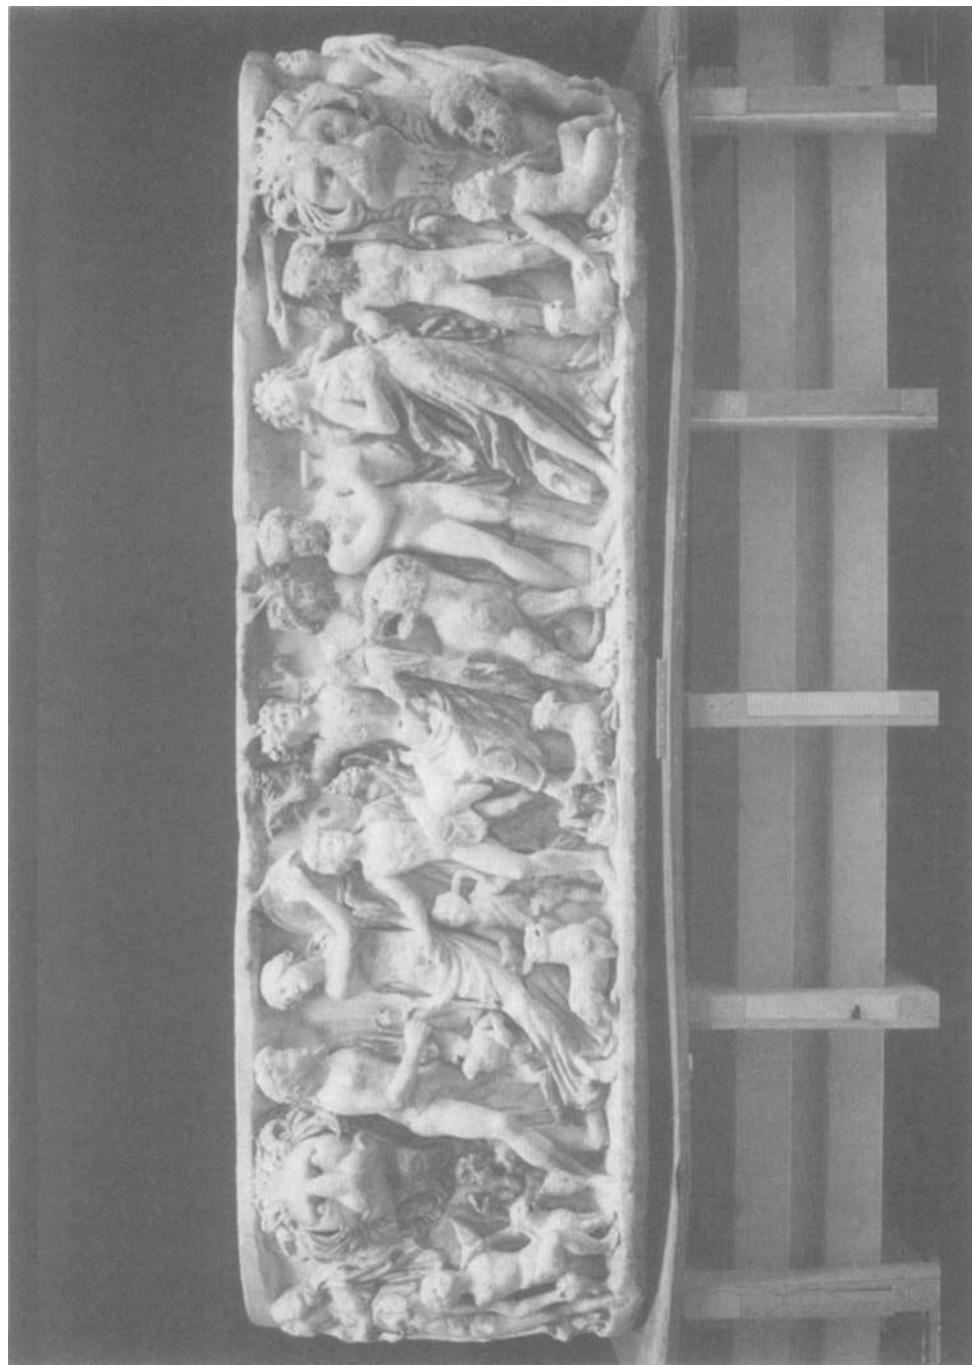
A Roman marble sarcophagus at the Los Angeles County Museum of Art (LACMA 50.37.11) had numerous gaps along old break edges that needed to be filled in 1982 (Figure 8). The wax-resin was applied to the primed stone edges in numerous areas with a heat spatula. The fills have been monitored since and have shown no signs of yellowing or cold flow, even at in vertical sites or at an overhang such as the underside of the rim (Figure 9 A & B).

Figure 8. Overall view of Roman sarcophagus (LACMA 50.37.11) after treatment in 1982.

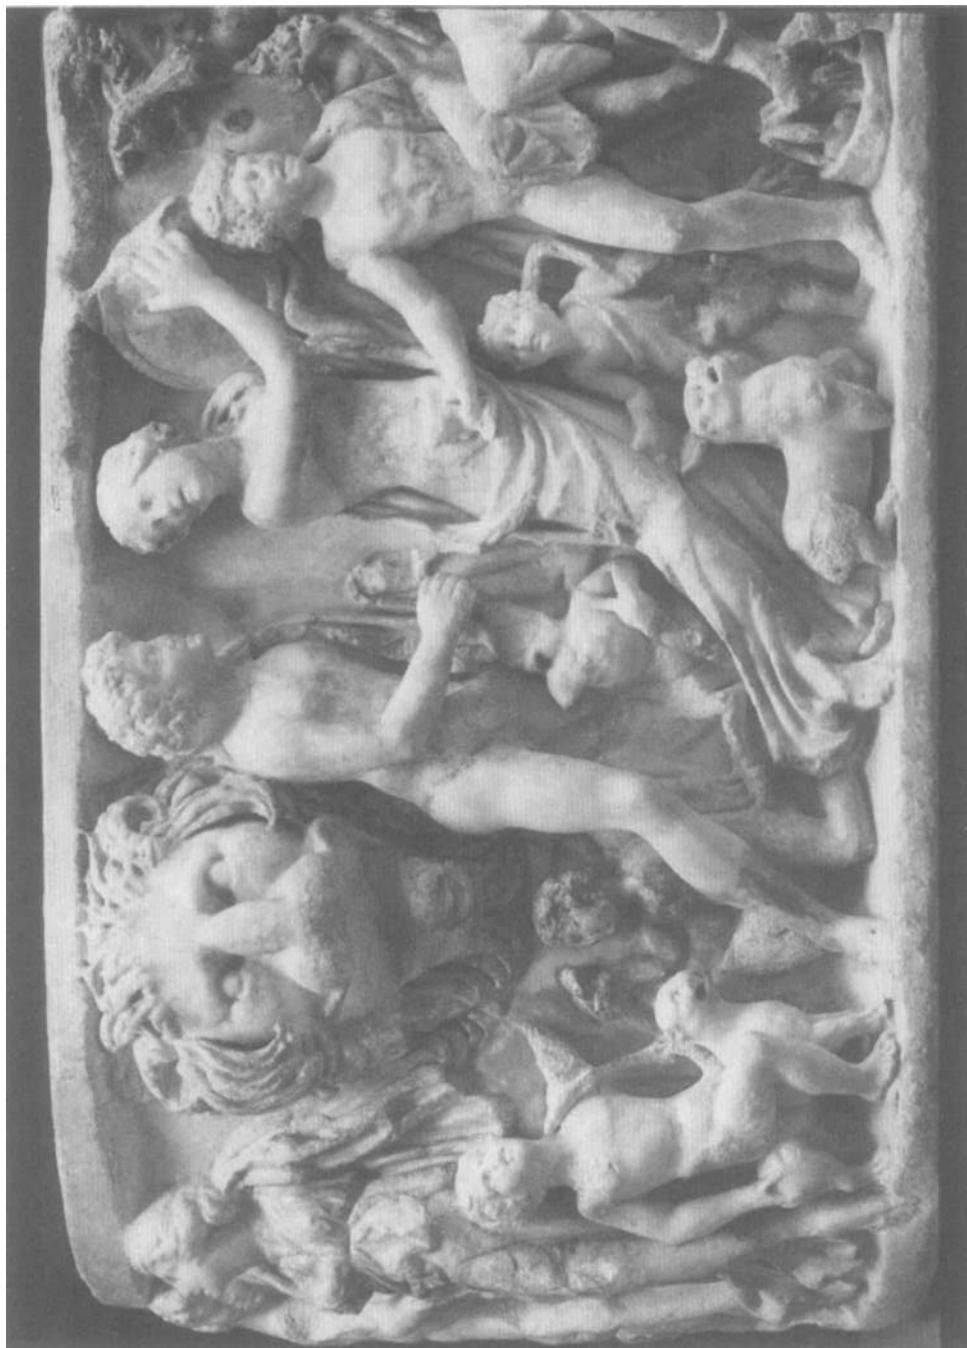
Figure 9A. Area where the wax-resin was applied on both vertical and an overhang in 1982 (LACMA 50.37.11).

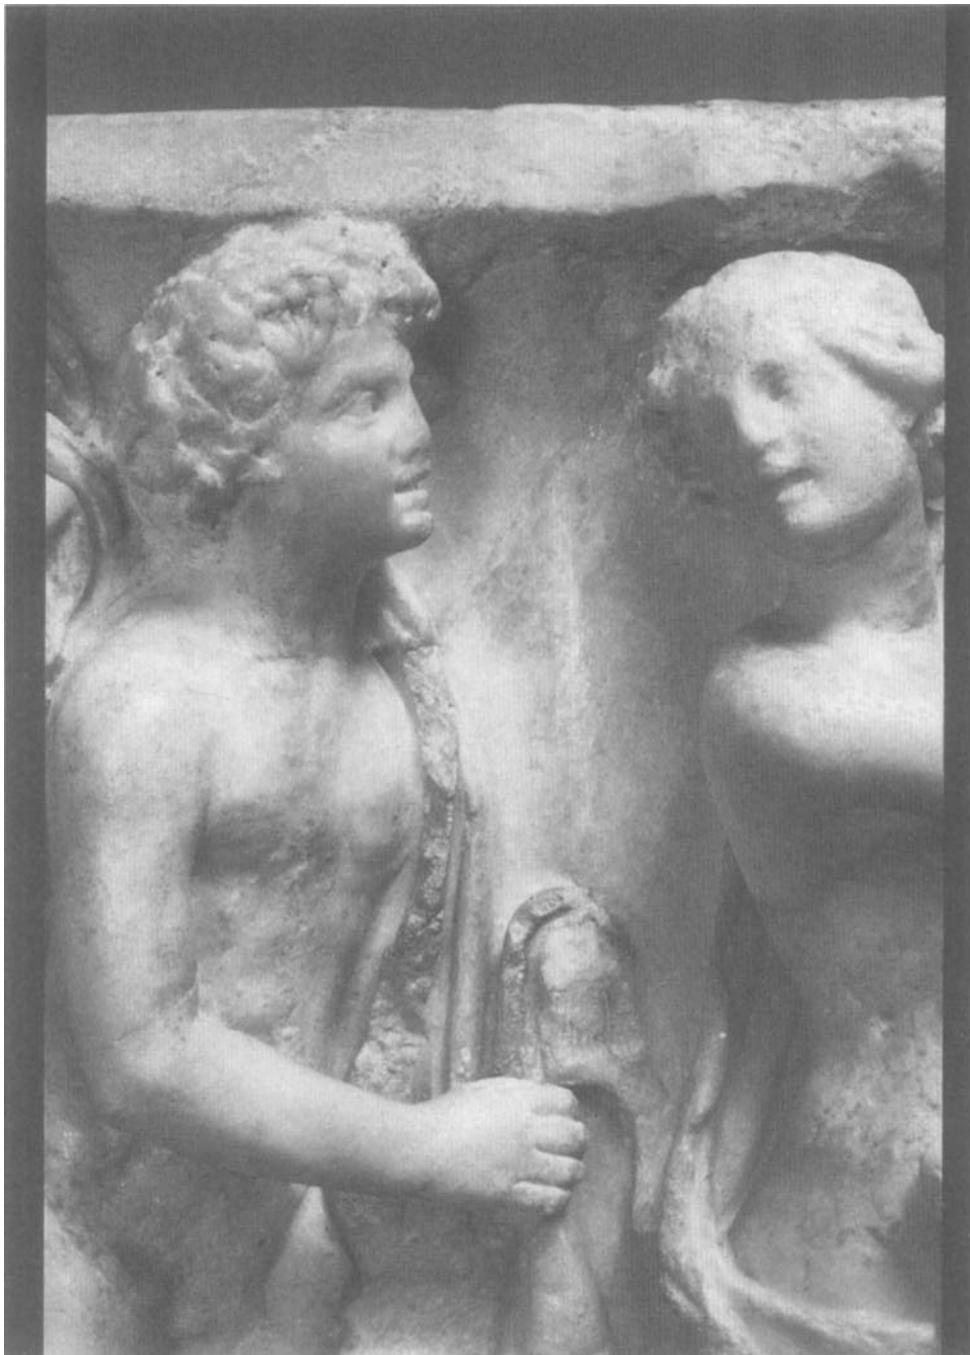
Figure 9B. Details of Figure 9A, taken in 1995.

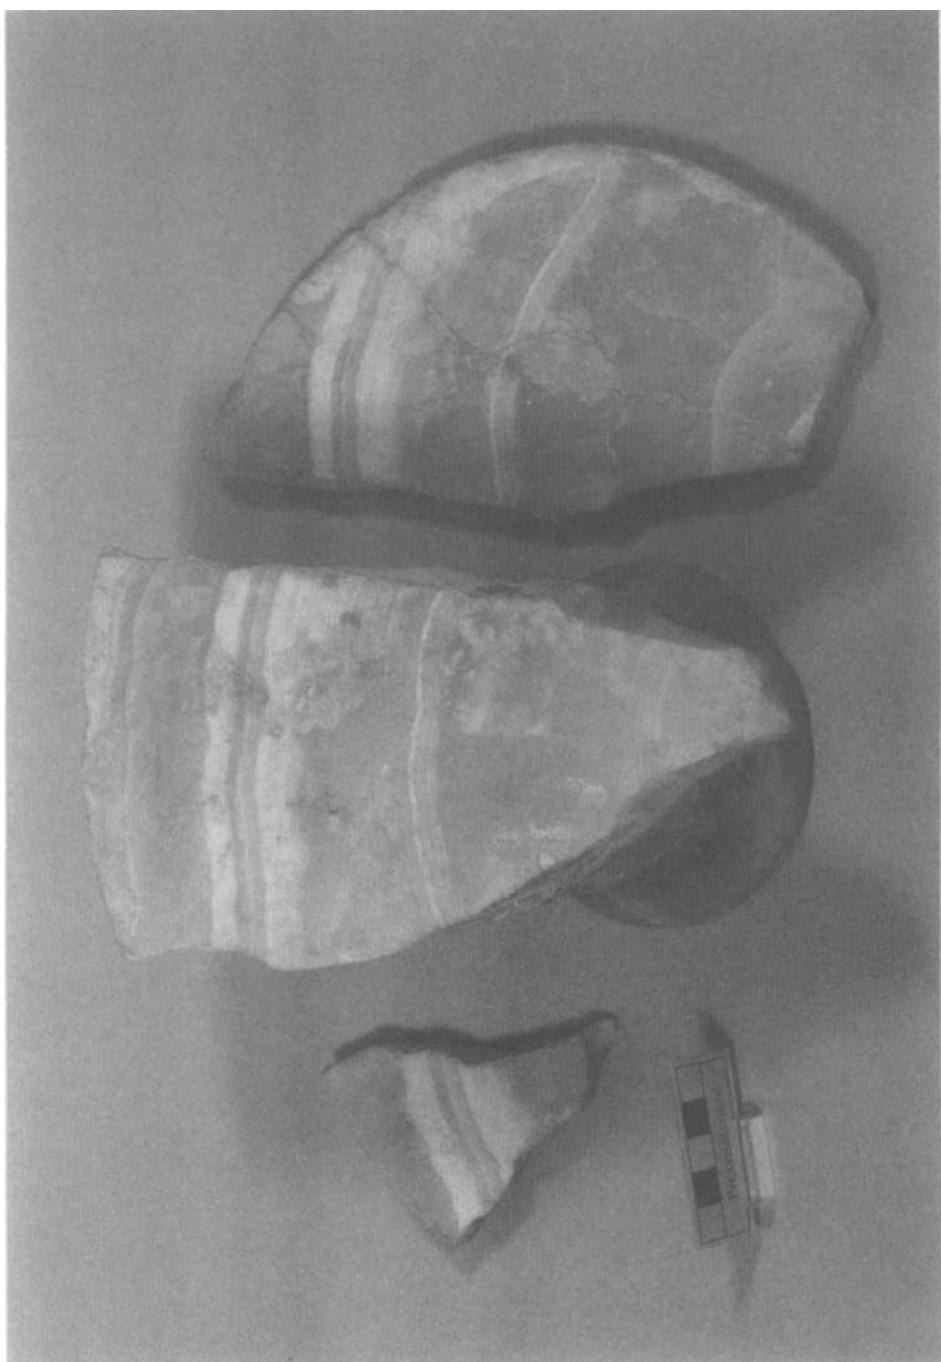
The top of the offering table was broken into four pieces; one third of it was lost and needed to be replaced. Plaster and other opaque materials would not fulfill the requirements, and an alternative to polyester and epoxy was sought. A large amount of the wax-resin was prepared and colored to match the ochre base color of the stone. The fill was initially cast as a thick monochrome piece within the break area, but was separated from the stone by aluminum foil. It was further molded with a hot spatula (Figure 11). In order to recreate the opaque white veining of the stone, grooves were carved into the ochre fill section, continuing the original bands. These were then filled with matching white opaque wax-resin, applied with a hot spatula.

Figure 10. Old Kingdom calcite offering table (MFA 11.2394) before treatment.

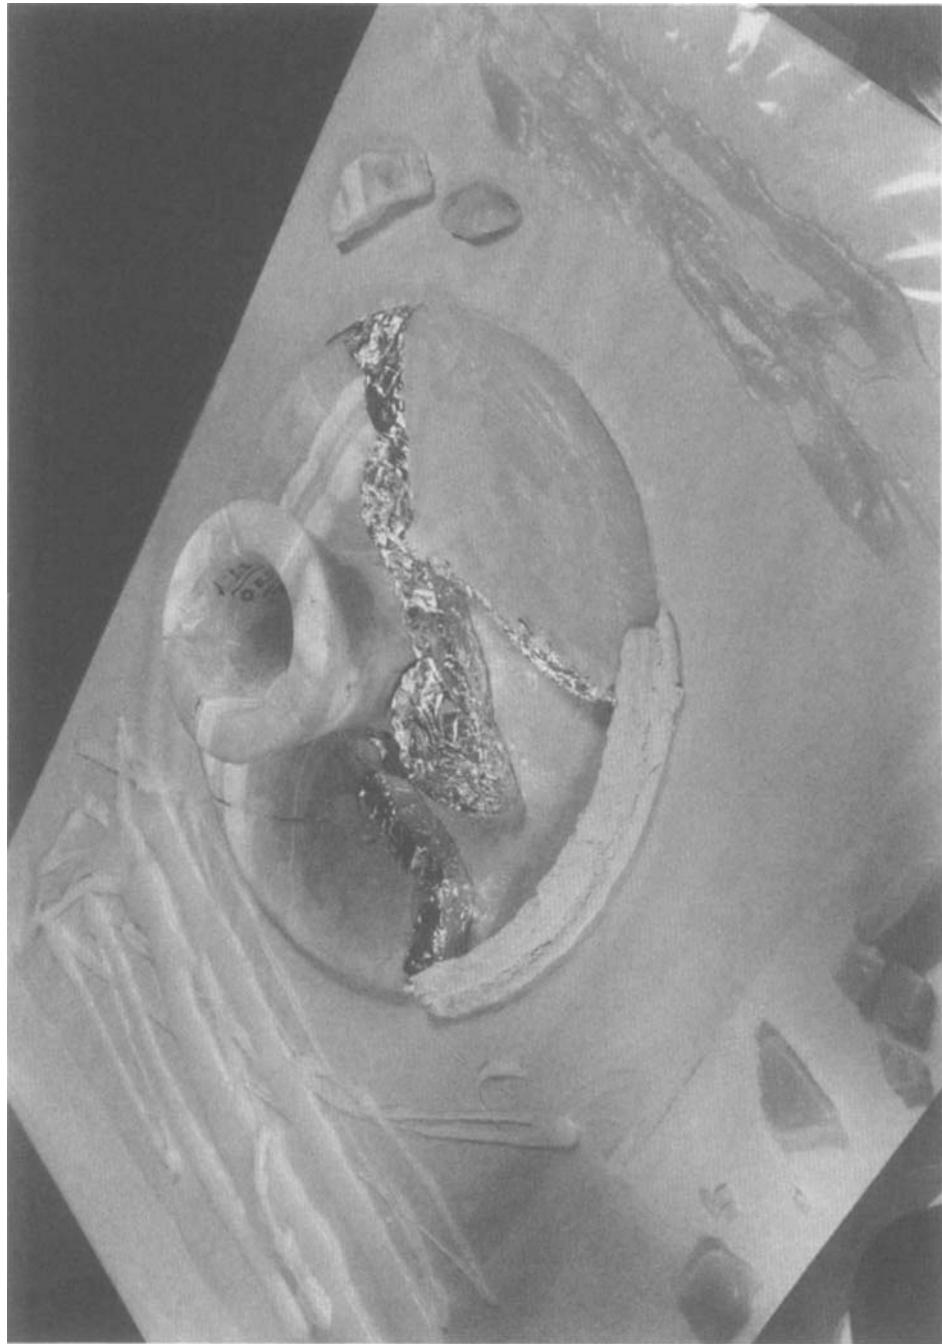
Figure 11. Offering table (MFA 11.2394) during filling.

These bands were slightly overfilled and the cooled surface was then shaped with sharp tools and sandpaper. Given the large size and weight of the fill section, a bond formed by PVA alone did not seem practicable. The fill was therefore adhered to the reconstructed stone table fragments with a two-component epoxy resin (Epo-Tek 301-2)¹³ after the break edges had been coated with Röhm & Haas Acryloid B-72 (Figure 12). The object has been on display in the MFA since 1988. While the color has not changed visibly, the fill has sagged noticeably (fig. 13). This certainly reveals the limitations of this material. If the treatment were to be repeated, perhaps it might benefit from a laminated fill incorporating a translucent core of another, more rigid,

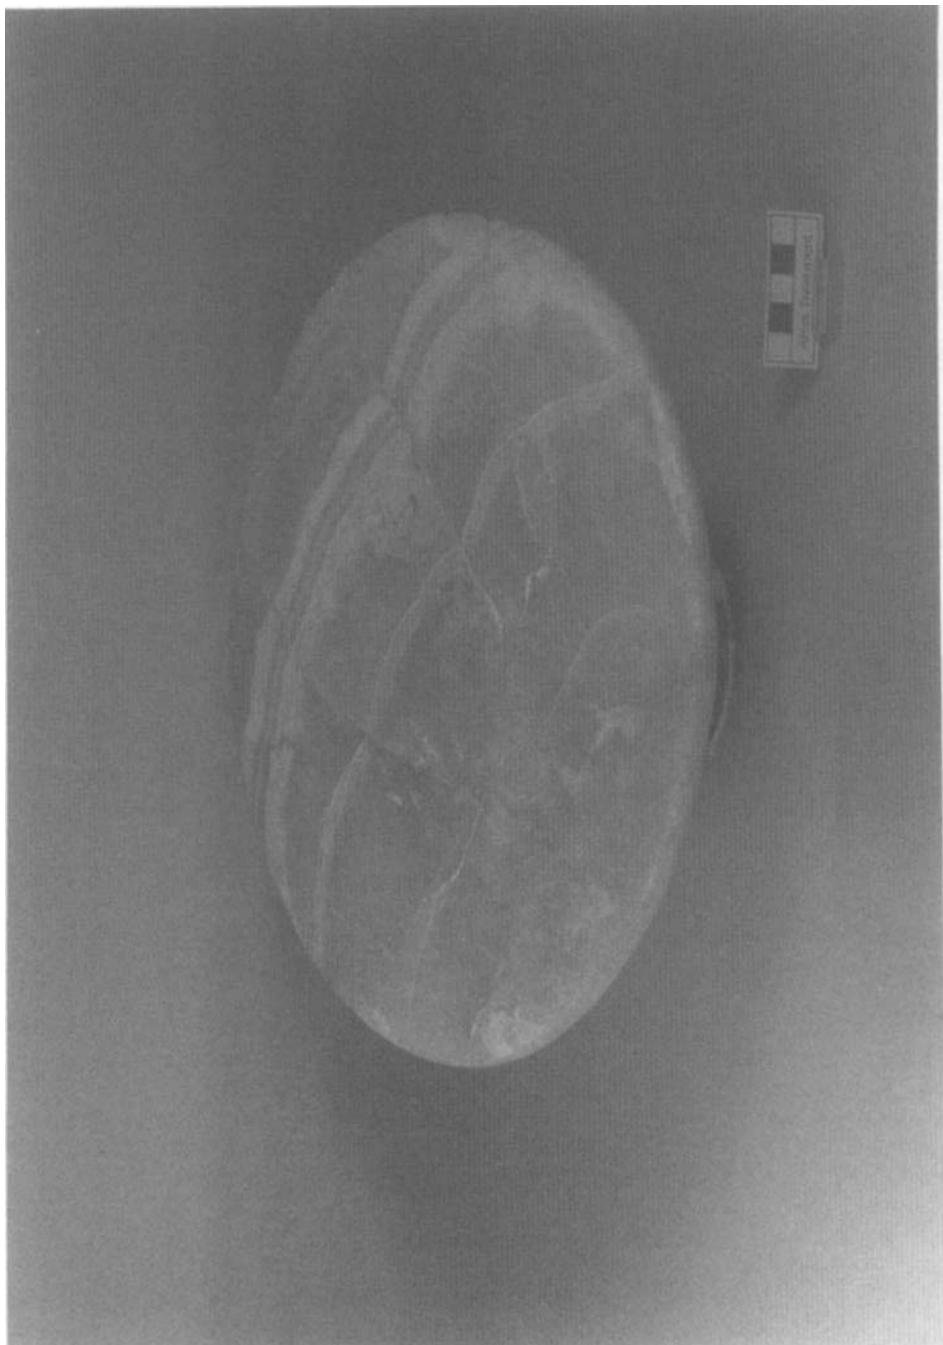
Figure 12. Offering table (MFA 11.2394) after treatment in 1988. Note the fill on the left side of the table.

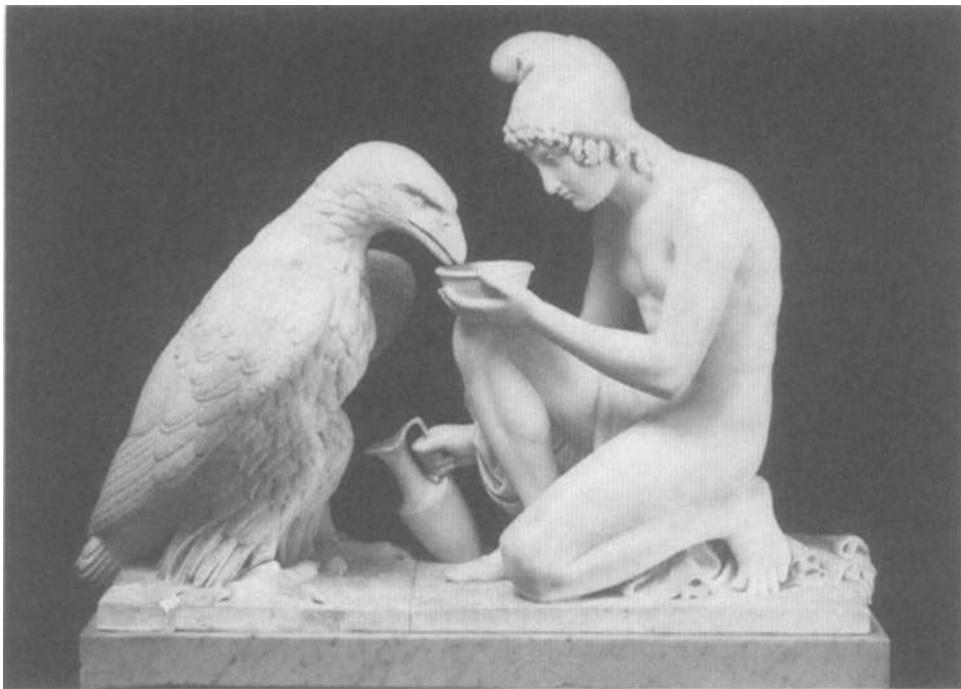
Another limitation of the material is that the wax-resin cannot mask underlying dark materials. This problem was encountered during the treatment of a group of nineteenth century white marble sculptures, recently acquired by the Chrysler Museum of Art, Norfolk, VA. Many of the sculptures had been previously restored. Large losses had been compensated with plaster and polyester resins cast in place. The plaster compensations crystallized in the stone, causing the break edges to become sugary and friable and, therefore, had to be removed. The plaster fills were replaced with removable subsurface Pliacre Epoxy Putty fills¹⁴, grey in color, over which the wax-resin was applied (Figures 14 & 15). The polyester fills aged to a dark greenish yellow color. Because it was cast directly onto the object, the resin migrated into and catalyzed within the stone, resulting in an irreversible interior dark band. Since the polyester fills could not be removed, they were mechanically pared down and recoated with the wax-resin to more closely simulate the appearance of the stone.

Figure 14. Ganymede and The Eagle, 1817, Bertel Thorwaldsen, The Chrysler Museum of Art Norfolk, VA, (86.525). Gift of James H. Ricau and Museum Purchase. Before treatment.

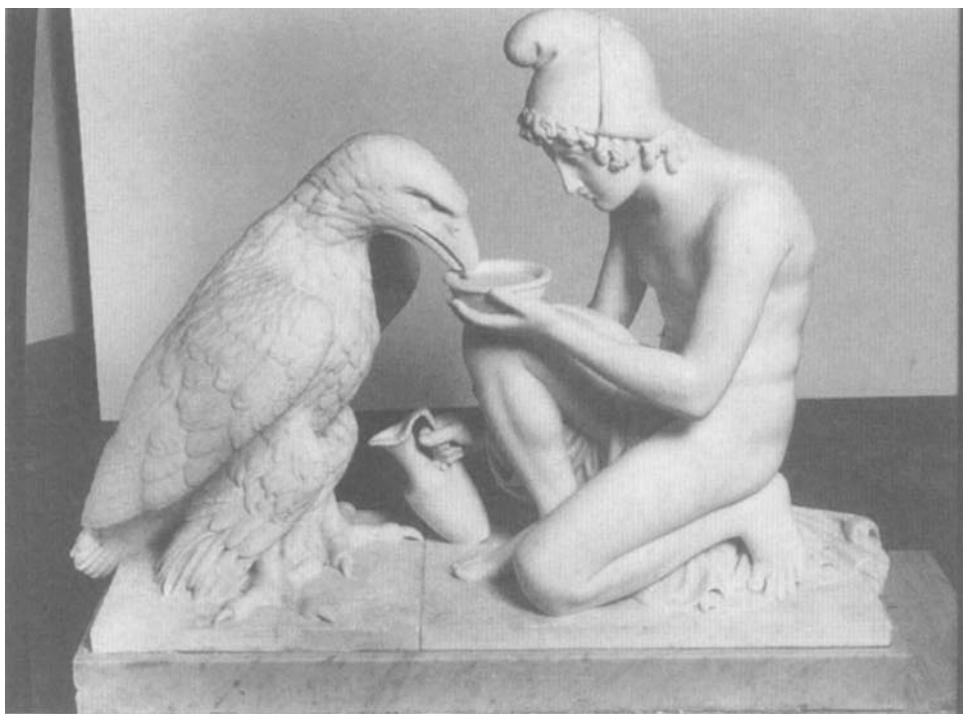
Figure 15. Ganyinede and The Eagle, 1817, Bertel Thorwaldsen, The Chrysler Museum of Art Norfolk, VA, (86.525). After treatment.
